# Service Bulletin

**Subject:** Rough Harsh Ride

**Models:** 2015 Cadillac Escalade Models  
2015 Chevrolet Tahoe LTZ, Suburban LTZ  
2015 GMC Yukon Denali Models  
With Magnetic Ride Control Suspension (RPO Z95)  
Vehicles Built Before 2/10/2015

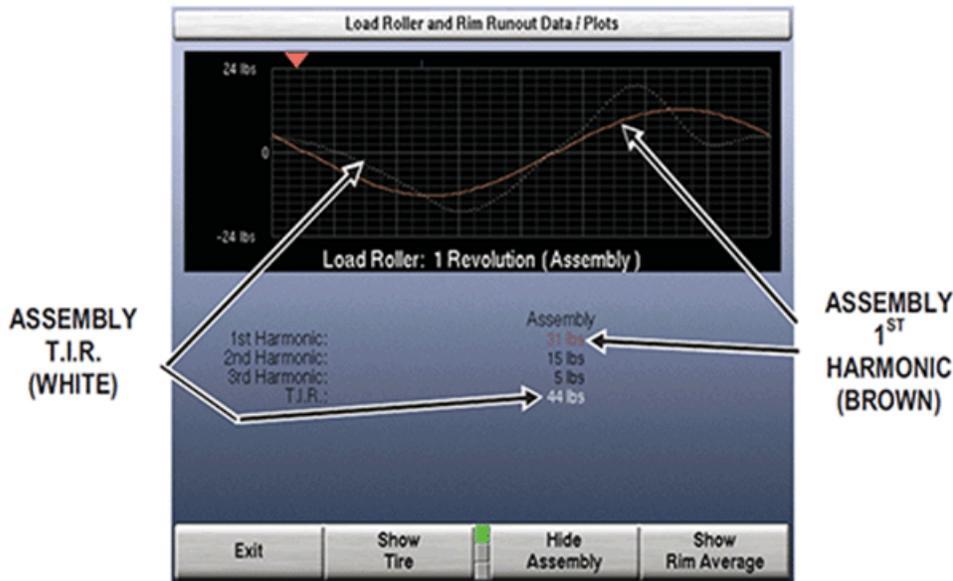
The GSP9700 checks tire low-speed RFV only, in the radial plane only

The GSP9700 is set to display T1 RFV. Higher order RFV, T2 & T3 can be displayed in the Assembly Data Plots Screen, as shown above. Depending on the level of GSP9700, the screen may be under 'Data' or 'Runout Plots,' then "Rim and Load Roller Runout Plots."

When checking tires on the GSP9700, if (radial) T2 is high or close to the (radial) T1 value, the tire should be replaced. As an example, if a tire and wheel assembly is measuring T1 at 10 lbs RFV, the tire would be considered good; however, if in displaying the higher orders, it is found that the tire and wheel assembly also has T2 at say 9 lbs RFV, the tire needs to be replaced. Refer to the latest version of PI1354 for latest procedures.
