Service Bulletin

PRELIMINARY INFORMATION

Subject: Headlight Performance (BCM Calibration and Bulbs)

Models: 2015 GMC Sierra
2014 GMC Sierra 1500

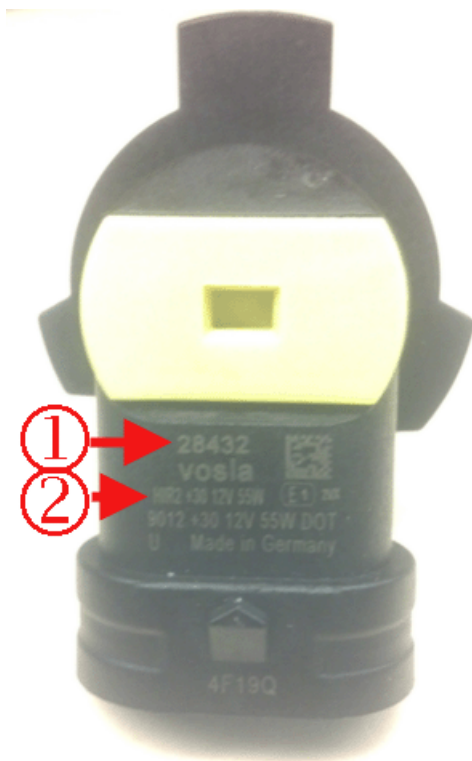
1. 28432
2. HIR2+30

1. For vehicles built before 12/23/14 at Flint Assembly (11th Vin Digit "F"), 1/13/15 at Silao Assembly (11th Vin Digit "G") or 1/16/15 at Ft. Wayne Assembly (11th Vin Digit "Z"), reprogram the BCM with the latest calibration available in TIS2WEB starting on 1/12/2015. The new BCM calibration will increase the voltage to the headlight bulbs in both the low beam and high beam selections. All vehicle build after the above dates already have the new BCM calibrations and the BCM reprogramming does NOT need to be done.
2. Replace both headlight bulbs with updated bulb part number 23342527. IMPORTANT: Verify the correct bulb is being installed by confirming the following markings on the bulb:

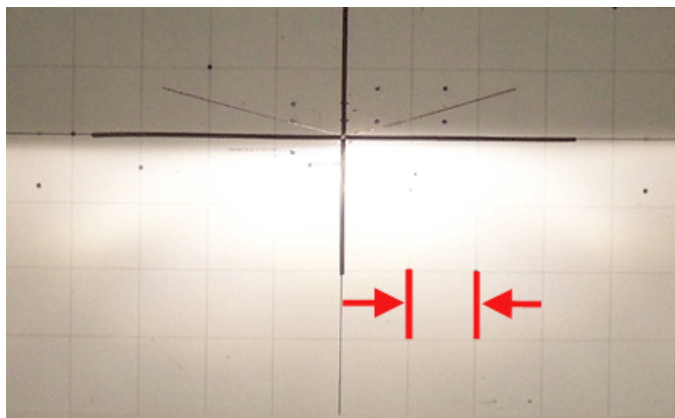
Important: When installing the new headlight bulbs, do not touch the glass and pay close attention that the bulbs are fully seated into the headlight housing. If the bulb is not properly installed it can lead to an incorrect light pattern. A beam pattern photo with a properly installed bulb is shown below. This photo is of a GMC Sierra Low beam pattern (1 Lamp with opposite lamp blocked) on wall/aiming screen at 25 ft (7.62 m). Each block division is approximately 10.5" (26.67cm)

3. After bulb replacement, perform Headlamp Aiming procedure (see below)

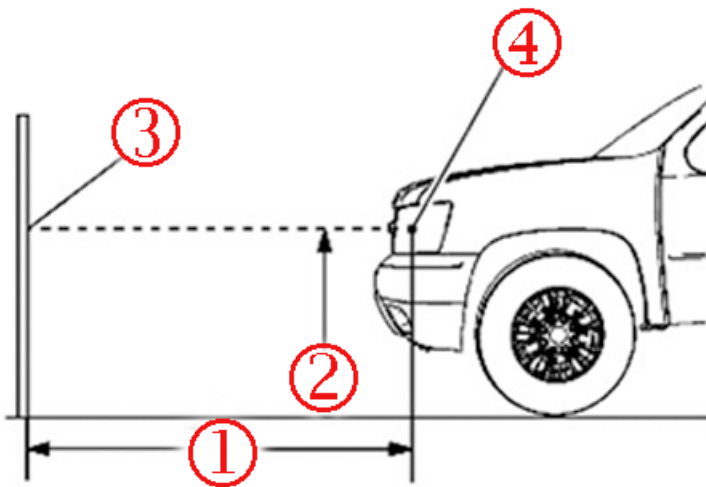
1. 25 ft (7.62 m)
 2. Height of Horizontal Aiming Line on screen
 3. Aiming Screen or Wall
 4. Reference mark (small circle) on headlamp lens
9. Turn the headlamps ON.
 10. Block the light from projecting onto the screen from the passenger side headlamp. This will allow the cutoff (“top” of the beam pattern) in the beam pattern from the driver’s side to be more pronounced for easier aim verification.
- Important:** DO NOT cover the headlamp, this may cause excessive heat buildup
11. On this vehicle you will be verifying the vertical aim of the cutoff (top of the beam pattern) on the right side of the “step” in the beam pattern.
 12. If the vertical location of the cutoff projected onto the screen or wall differs from the figure below, then an adjustment to the beam pattern location is necessary.

1. Position the vehicle directly in front of the screen or wall at a distance of 25 feet.
 2. Remove any snow, ice or mud from the vehicle.
 3. The vehicle should be fully assembled and all other work stopped while the headlamp aiming is being done.
 4. The vehicle should contain cargo or be loaded to represent normal vehicle use.
 5. Tires should be properly inflated.
 6. Rock the vehicle to stabilize the suspension.
 7. Measure from the floor to either headlamp reference mark
- Note:** If the reference mark (small circle) cannot be seen on the headlamp lens, measure from the floor up to the center of the headlight projector eye ball.
8. At the screen, measure from the floor and place the horizontal tape at the measured height. This establishes the Horizontal Aiming Line.

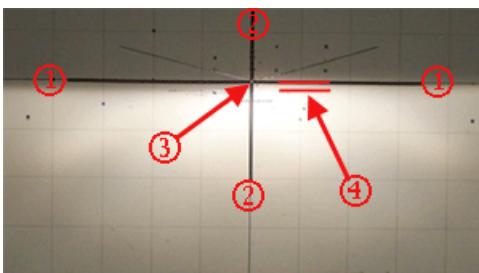
Note: GMC Sierra Low beam pattern (1 Lamp) on wall/aiming screen at 25 ft (7.62 m)

1. Horizontal Aiming Line
 2. Reference line only, Not needed for proper aiming
 3. Step in beam pattern
 4. Top of beam pattern (cutoff line) positioned at the horizontal aiming line +0 / -0.75" (-19mm)
13. Adjust the vertical headlamp aim adjustment screw until the cutoff (top of the beam pattern) on the right side of the beam pattern step is set between the Horizontal Aim Line and 0.75 (19mm)inches below.
 14. Repeat the aiming procedure for the passenger's side headlamp while blocking the light from projecting onto the screen from the driver's side headlamp
