Service Bulletin

Subject: OnStar XM GPS or Antenna Malfunction - May Set DTC B2462 B2470 Or B125C - Water Leak In Headliner Or Overhead Console

Models: 2015 Cadillac Escalade Models
2015 Chevrolet Silverado, Suburban, Tahoe
2015 GMC Sierra, Yukon Models
Equipped with High Frequency Painted Antenna Assembly
Built Before:
3/24/15 if 11th vin digit = "F"
3/2/15 if 11th vin digit = "G"
2/26/15 if 11th vin digit = "R"

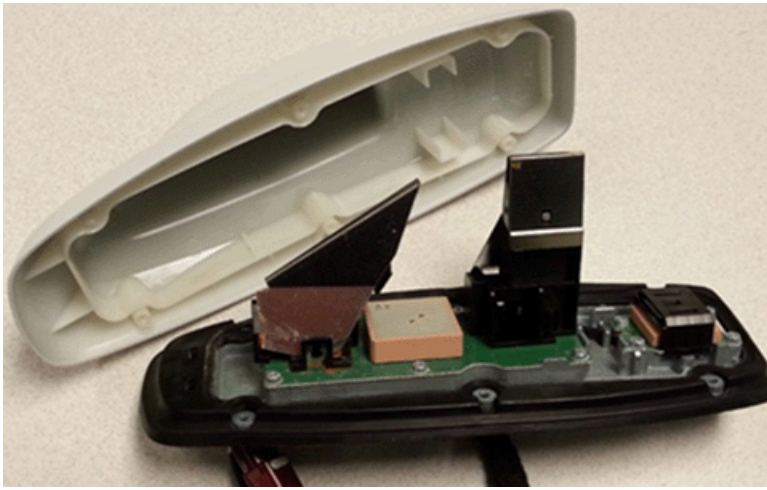
Note: This recommendation only applies to vehicles equipped with the high frequency "painted" antenna assembly after built before the dates listed. Engineering has identified an issue of water intrusion into the body of the antenna assembly which can ultimately travel down the wiring pigtail into the vehicle. There have also been cases of water leaks from underneath the antenna at the roof panel opening. Inspect the roof sheet metal to ensure there is no deformation at or near the antenna pass-thru opening

If the antenna performance concerns outlined and/or one of the water leak concerns are encountered, replace the antenna ensuring to use the latest antenna part number available from CCA parts without removing the cover from the base.

Important: The painted antenna cover is NOT intended to be removed. Do Not remove the antenna cover from the antenna base, as this may compromise the sealing performance of the new part.

Note: DO NOT use and any form of Sealants on the replacement antenna cover, seals or gaskets.
