Bulletin No.: PIT5433A

# **Service Bulletin**

**Subject:** Front Floor Carpet Wet

Models: 2015 Chevrolet Silverado 1500

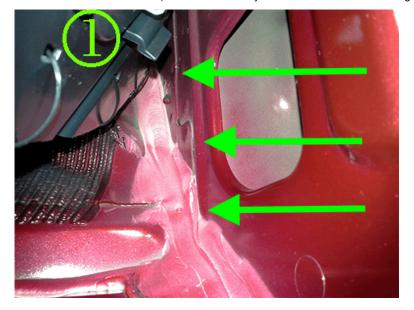
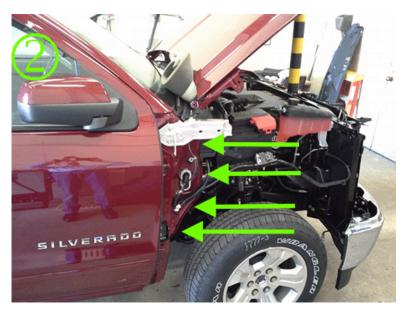
Pull back carpet on affected side (left or right) at kick panel and water test. If the leak is found to be coming from the seam (1) at the front kick panel (right side shown below - left side similar) it will be necessary to remove the front fender to gain access to the vertical cowl seam (2) that is leaking.
