Service Bulletin

PRELIMINARY INFORMATION

Subject: Vibration Or Shudder On Acceleration From A Stop

Models: 2013-2016 Cadillac XTS with All Wheel Drive (AWD)
2014-2016 Buick Regal with All Wheel Drive (AWD)

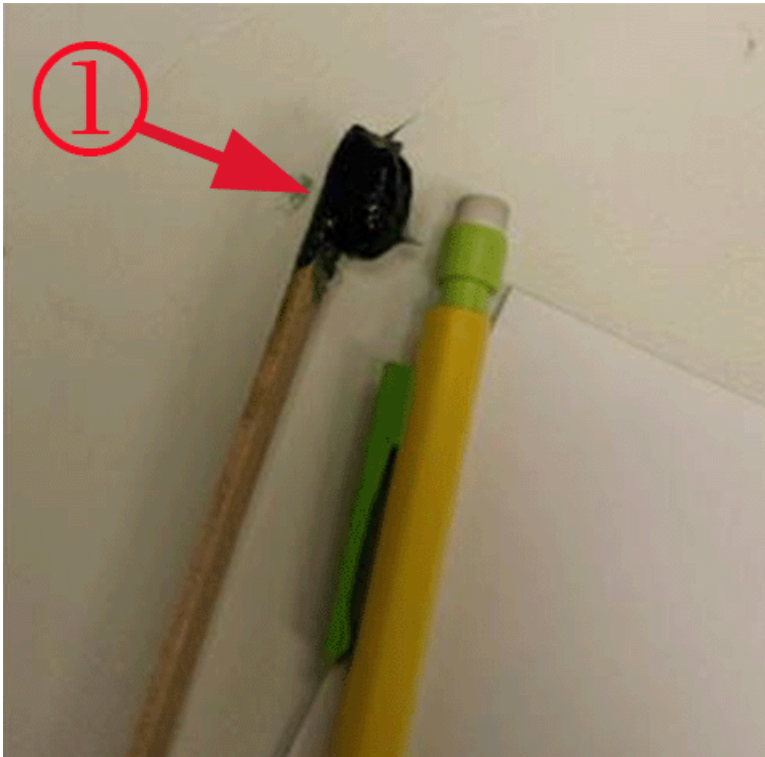
1/2 gm of grease is shown below. Do not exceed 1.5 gm total.

Remove all grease from the transfer case intermediate drive shaft (IDS) internal splines and axle shaft splines. Apply total of 1 gm grease on IDS splines: 0.5 gm in two 120 degree quadrants each, 180 degree apart. Ensure the other two adjacent quadrants have splines free of grease. Apply grease within 15 mm of leading spline edge and do not apply in the retaining ring groove.
