Service Bulletin

PRELIMINARY INFORMATION

Subject: Reduced Power Steering Assist Engine Stall IPC / Radio / HVAC Goes Blank Various DTCs

Models: 2015-2016 Cadillac Escalade Models
2014 Chevrolet Silverado 1500
2015-2016 Chevrolet Silverado, Suburban, Tahoe
2014 GMC Sierra 1500
2015-2016 GMC Sierra, Yukon Models

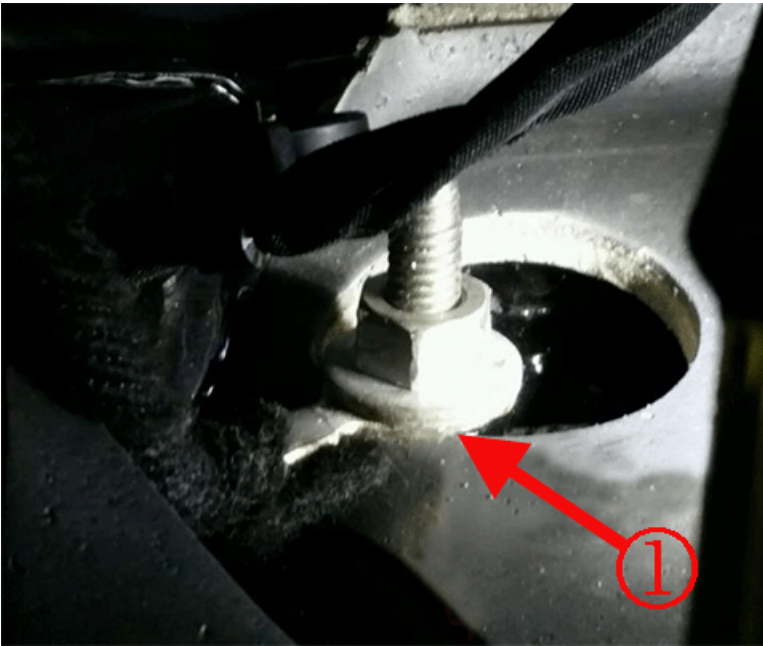
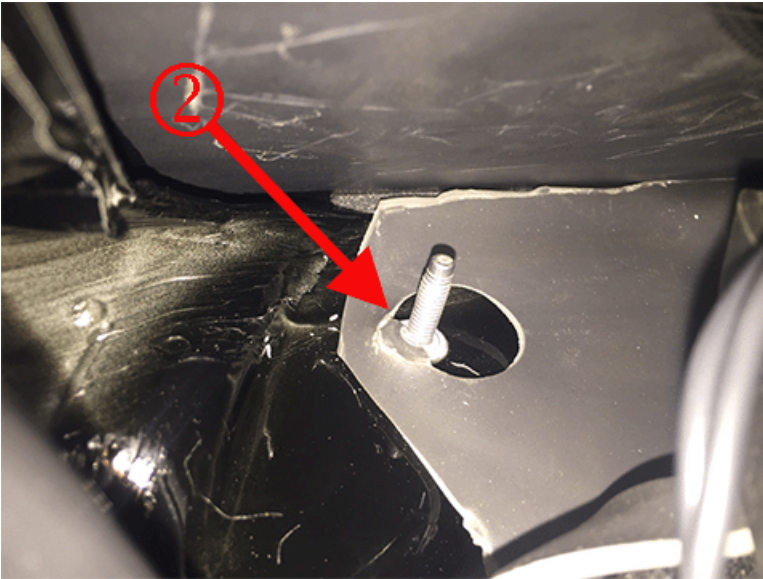
1. A poor BCM ground at G218.
2. A shorted B+ Battery cable at the Starter Solenoid.
3. High resistance/loose connection at the battery fuse block or battery cables

1. Inspect G218 for a loose connection or the front of dash insulator mat (2) for being trapped between the ground eyelet and the body/stud as shown below (1). If the dash insulator mat is trapped, cut the mat away from the ground stud so it will no longer interfere. Reinstall the ground eyelet, the nut, and retighten.
