# Service Bulletin

**Subject:** Passenger Seat Airbag Warning Message On, DTC B0081 00 and/or B0074 Set

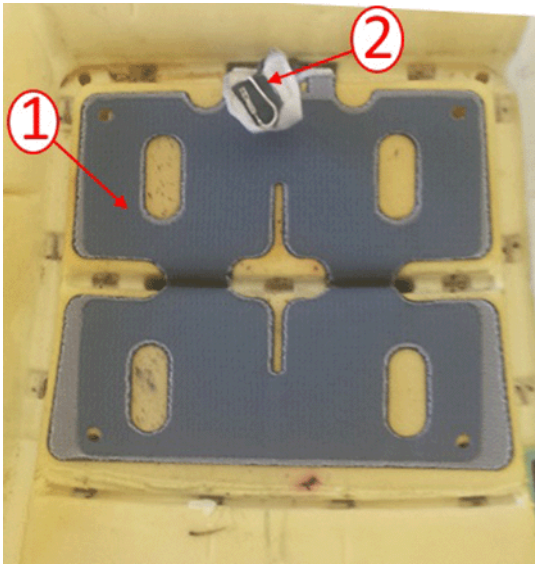
**Note:** To gain access to the passenger presence sensor mat (1) and electrical terminal (2), removal of the seat cushion from the seat frame is required.

1. Remove the passenger side seat. Refer to *Driver or Passenger Seat Removal and Installation* in SI.
2. Remove the seat cushion cover from the seat cushion.
3. Using care, pull the sensor tail up through the foam opening.
4. Using care, remove the felt tape from the terminals.
