PIT5501E Steering Feels Loose / Excessive Lash / Fluid Leak At Lash Adjuster

## Product Investigation Review Required

Brand:	Model:	Model Years:	VIN:		Engine:	Transmissions:
			from	to		
Chevrolet	Silverado 2500/3500	2016 - 2017	All	All	All	All
GMC	Sierra 2500/3500	2016 - 2017	All	All	All	All

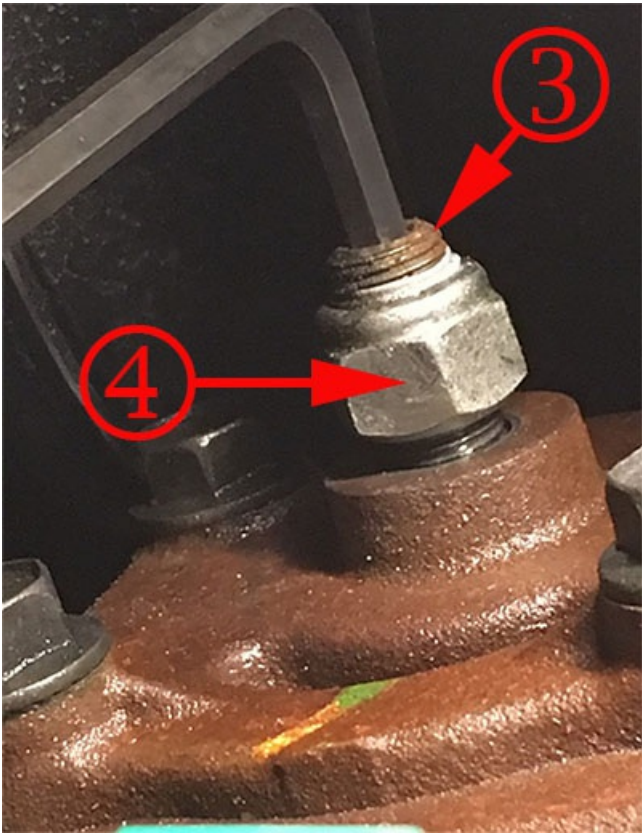
These concerns could be caused by the pitman shaft adjuster stud (3) unthreading up/out of the cover plate, which can cause excessive lash in the steering gear. This issue is NOT caused by the lock nut (4) turning on the adjuster stud (3), shown below.

- The adjuster stud nut (4) will not be seated up against the cover plate, shown below.
- The adjuster stud (3) can easily be turned in or out by hand using an Allen wrench.

If it is found that the pitman shaft adjuster stud (3) has unthreaded up/out AND there is NO reason to believe someone has previously turned the adjuster stud nut (4) on the adjuster stud (3), continue to the recommendations section to apply thread locker on the adjuster stud threads.

If any lash/play is found, OR there IS reason to believe someone has turned the adjuster stud nut (4) on the adjuster stud (3), follow the SI procedure titled "Steering Gear Pitman Shaft Over-Center Preload Adjustment - Off Vehicle (Heavy Duty)".
