Service Bulletin

Subject: A/C Inoperative, Blows Warm or Poor Performance Due to Low Refrigerant Charge, Freon Leak

Brand:	Model:	Model Year:		Breakpoint:		Engine:	Transmission:
		from	to	from	to		
Buick	Enclave	2013	2016	Vehicles Built Prior to October 6, 2015		All	All
Chevrolet	Traverse	2013	2016				
GMC	Acadia	2013	2016

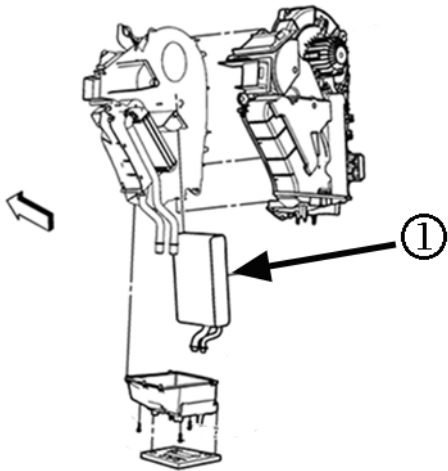
Condition	Some customers may comment that the A/C is blowing warm, is exhibiting poor performance or of a general lack of air conditioning, or low charge.
Cause	The cause of this condition may be that, during operation, the auxiliary evaporator blower motor may emit brush dust that contains some copper particles. These particles could lead to accelerated corrosion to the auxiliary evaporator and a small refrigerant leak.
Additional Options	Equipped with Auxiliary Air Conditioning (RPO CJ2)

1. Remove the auxiliary a/c evaporator (1). Refer to *Auxiliary Air Conditioning Evaporator Replacement* in SI.
