# Service Bulletin

**Subject:** Rear Vision Camera Brightness Adjustment

Brand:	Model:	Model Year:		VIN:		Engine:	Transmission:
		from	to	from	to		
Buick	Verano, Encore	2013	2016

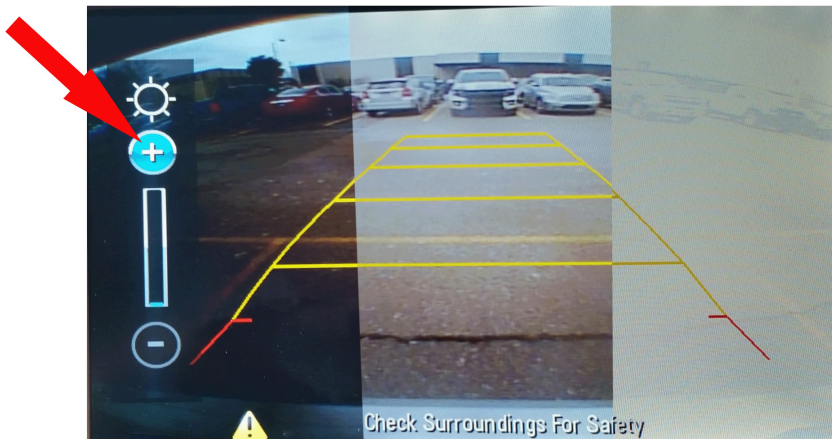
### Correction

<b>Condition</b>	Some customers may comment that the rear vision camera image is dark.
<b>Cause</b>	This condition may be caused by the BRIGHTNESS level not set to the correct level.
<b>Additional Options</b>	RPO UVC

While viewing the rear vision camera image, Press the MENU button to adjust brightness. **Do not** replace the rear vision camera for this issue. For further information on brightness control, refer to the Driver Assistance Systems in the Owners Manual.
