SERVICE BULLETIN

APPLICABILITY: 2010~2013MY Legacy and Outback equipped with Sunroof
SUBJECT: Water Leak from the Map Light Area

NUMBER: 12-117-10R
DATE: 03/30/10
REVISED: 08/28/17

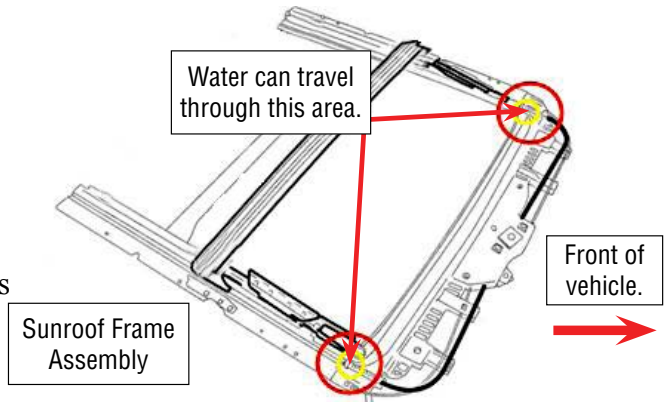
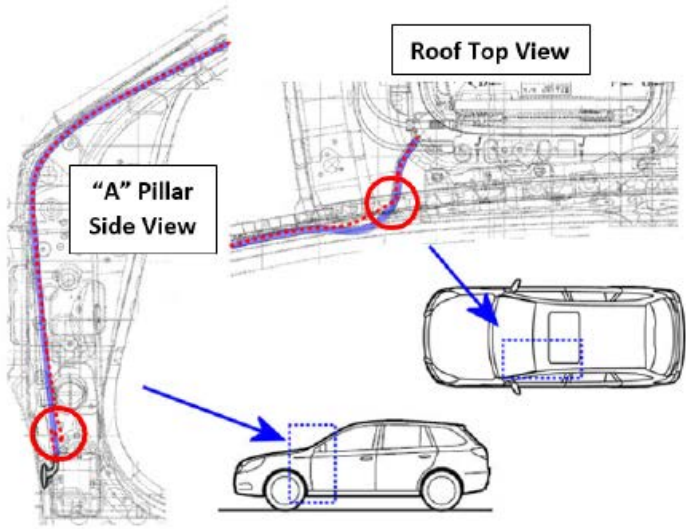
The Sunroof drain hose(s) may be kinked in the circled areas.
 ---- : OK : NG

- Open the sunroof completely and water test each drain by **carefully** pouring water into the front corner areas of the sunroof frame where the drain hoses connect. The water should flow freely through the drains and hoses as it is poured, exiting the vehicle at the base of the corresponding side “A” pillar area. If a drain or hose is blocked or clogged, **careful** application of compressed air may free the restriction. If a drain hose is determined to be kinked or the blockage cannot be cleared, replace it following the procedure in the applicable Service Manual.
