PIC6285 Diagnostic Aid for DTCs P1AEE and P1AEF, Control Module Hybrid/EV Battery System Voltage High Voltage (Over-Voltage)

Models

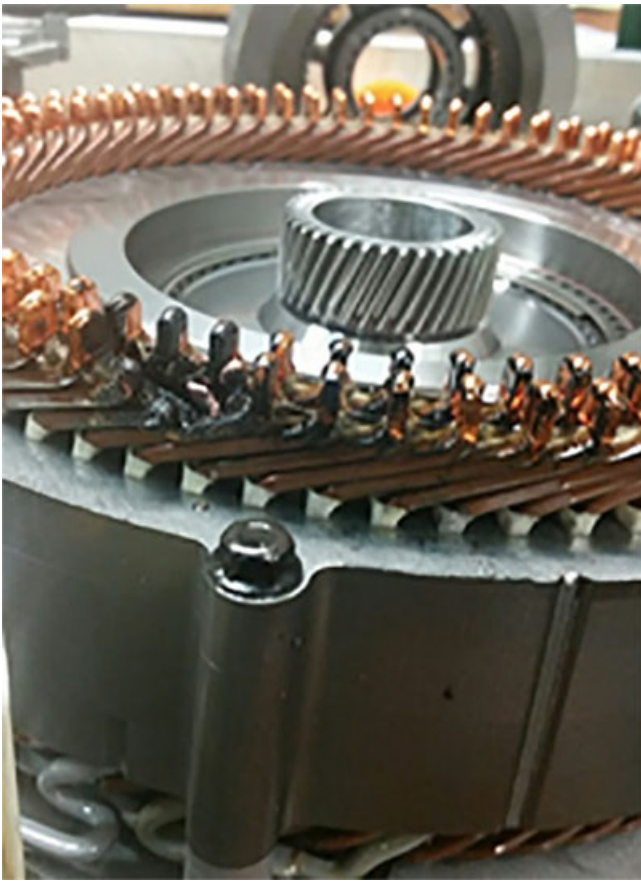
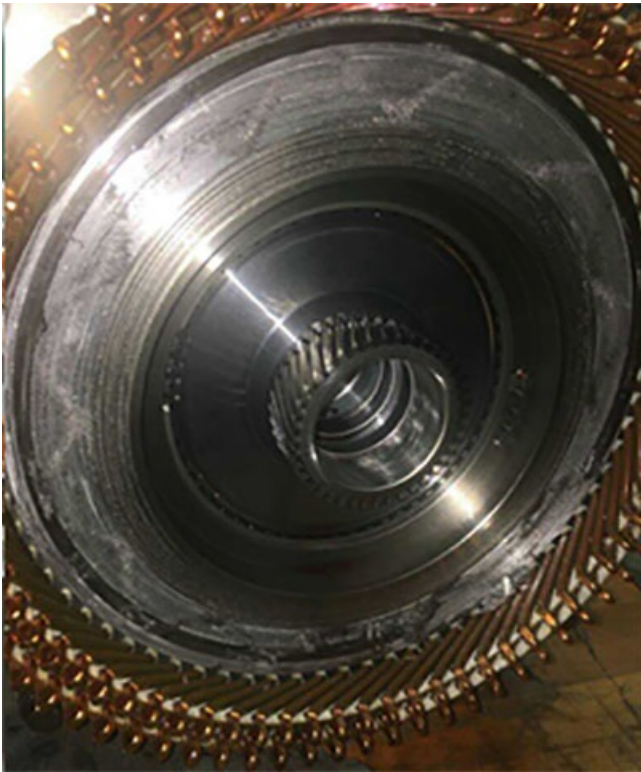
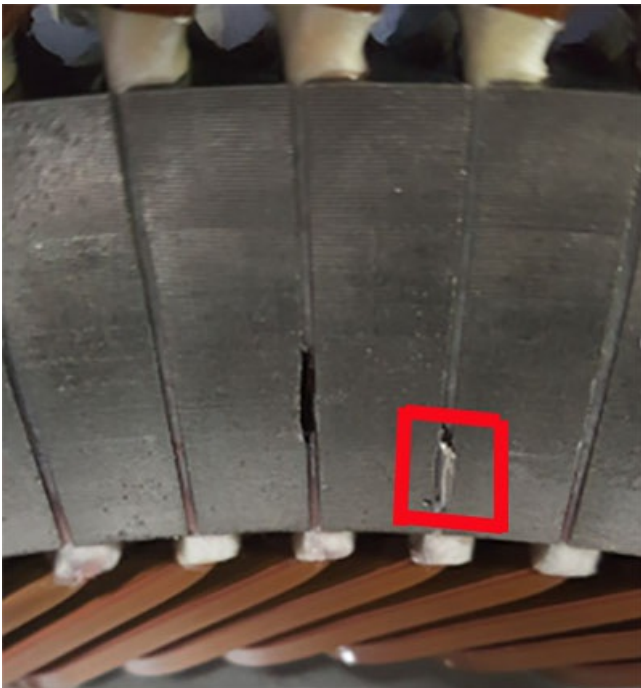
If one of these parameters is 0 volts in the freeze frame, then it is likely the vehicle has a loss of isolation condition. If accompanied by DTCs P1AF0/P1AF2/P1E22 or P0C01/P0C04, then the loss of isolation will be located within the transmission, usually due to debris in the motor stators from a failed internal component. Without the accompanying DTCs, the loss of isolation could be anywhere within the high voltage system, but the transmission is still suspect. Use the *Loss of Isolation on the High Voltage Main Bus* procedure in SI to help pinpoint which subsystem is causing the loss of isolation. Using the vehicle data to help determine the loss of isolation is preferred to troubleshooting with an insulation multimeter due to the intermittent nature of most failures.

Examples of debris causing stator problems:

Note: Any loss of isolation will not self-heal and needs to be repaired for vehicle safety. Clearing codes without repair is not an acceptable remedy of this category due to the vehicle hazards created by P1AEE and P1AEF.

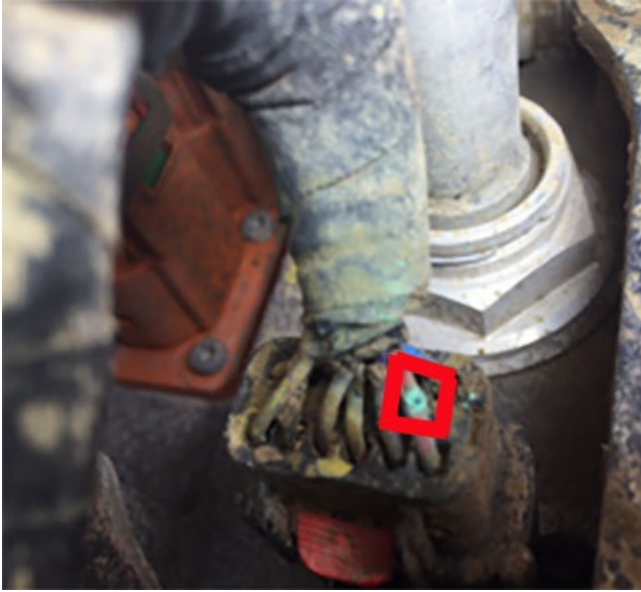
battery opened unexpectedly while the vehicle was driving. The vehicle may also have a P0AA1 and P0AA4 set for this category. If the HPCM2 also stored DTC P0A0C at the same time as P1AEE and P1AEF, then follow published Service Information for P0A0C first. The HPCM2 has direct control of the contactors. Issues with the HPCM2 or wiring could lead to P1AEE and P1AEF. Inspect circuits 3961 and 3959 for contactor control as well as B+ 5240 and ground circuit 2050 (G302). Any compromise in these circuits may cause the contactors to open unexpectedly. If no trouble is found, replace the K114B HPCM2 module for a possible internal fault with contactor control.

Example of connector X357 with stone impingement and corrosion on wiring:

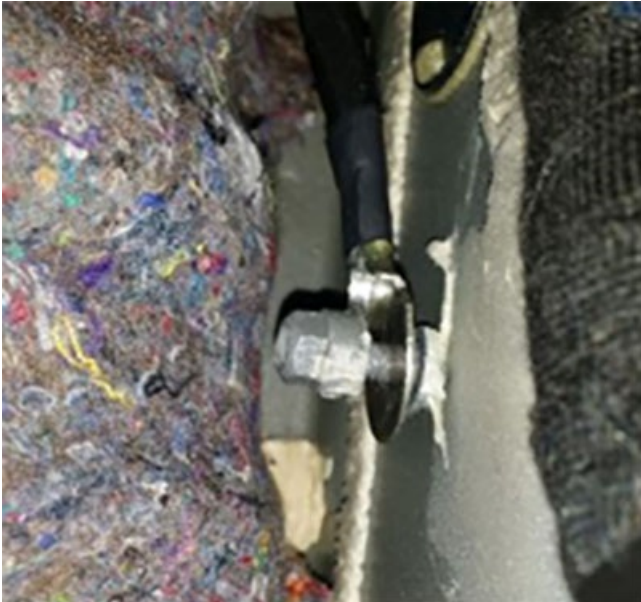
Example of loose ground G302:

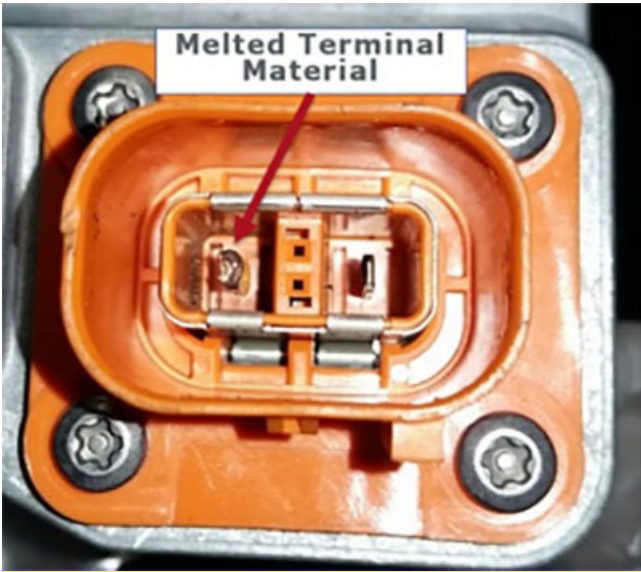
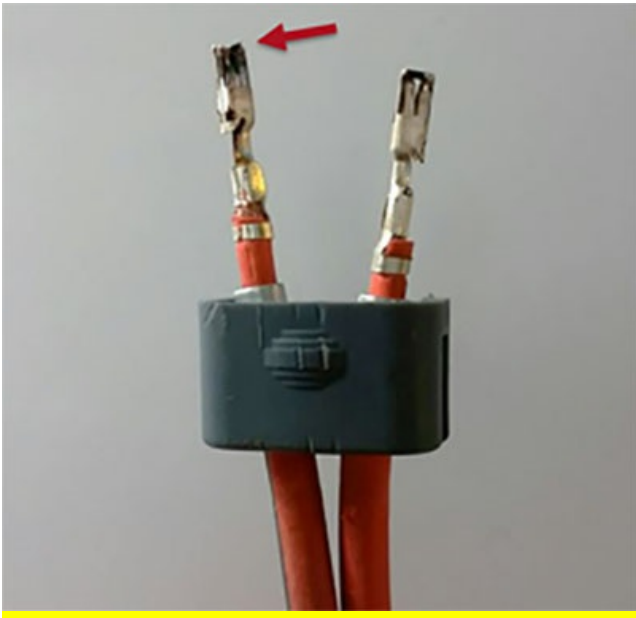
This is expected to be a less common category for P1AEE and P1AEF. If one of the parameters is near but not equal to zero, properly inspect each of the orange high voltage connectors on the vehicle for a loose connection on the high voltage bus.

Example of a loose connector X2 at the K10 Coolant Heater Control Module:
