PIC6065B Diagnostic Tip: Performance Data Recorder SD Card Not Recognized

Brand:	Model:	Model Years:	VIN:		Engine:	Transmissions:
			from	to		
Cadillac	ATS-V	2016 - 2018	All	All	All	All
Cadillac	CTS-V	2016 - 2018	All	All	All	All
Chevrolet	Camaro 1LE	2017 - 2018	All	All	All	All
Chevrolet	Camaro ZL1	2017 - 2018	All	All	All	All
Chevrolet	Corvette	2015 - 2018	All	All	All	All

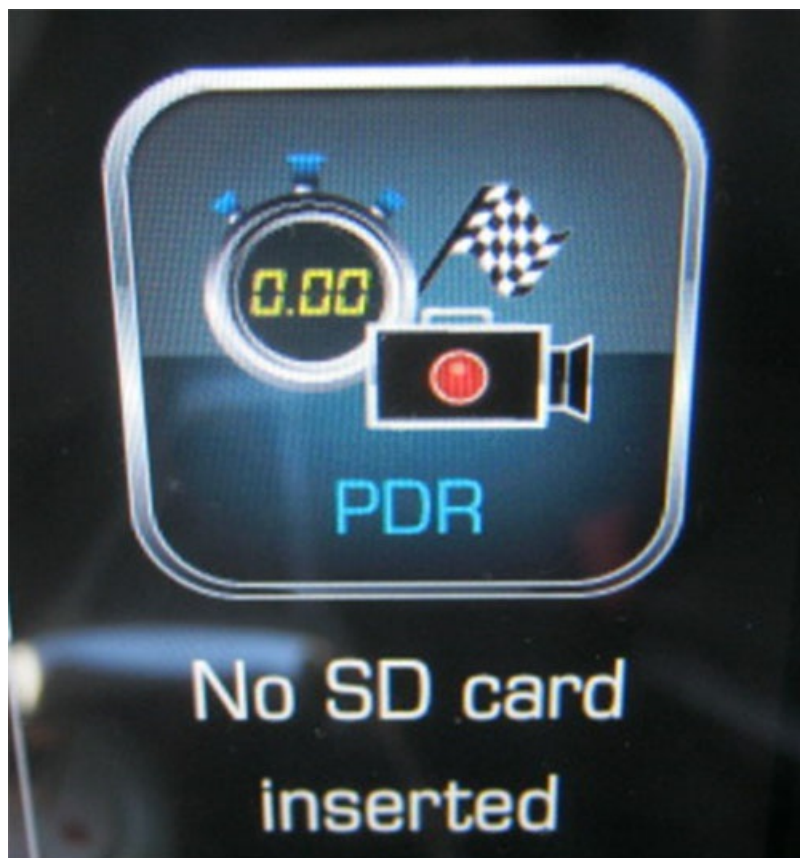
Customers may comment that the vehicle does not recognize the SD card when it is inserted into the card reader. The Performance Data Recorder (PDR) menu will also display the message, "No SD card inserted" as seen in the photo below.

When diagnosing this concern, the first thing that should be checked is which SD card reader has been used by the customer. On most vehicles with the PDR system, there are multiple SD card readers. Dealership technicians are to visually inspect the vehicle for multiple SD card reader locations. As an example, the Corvette has a media SD card reader in the center console. The SD card reader for the PDR system however, is located in the glovebox. The Camaro only has one SD card reader and it is located on the driver's side knee bolster. Refer to published Service Information (SI) to be certain the correct SD card reader location is being used for the vehicle that is being serviced.

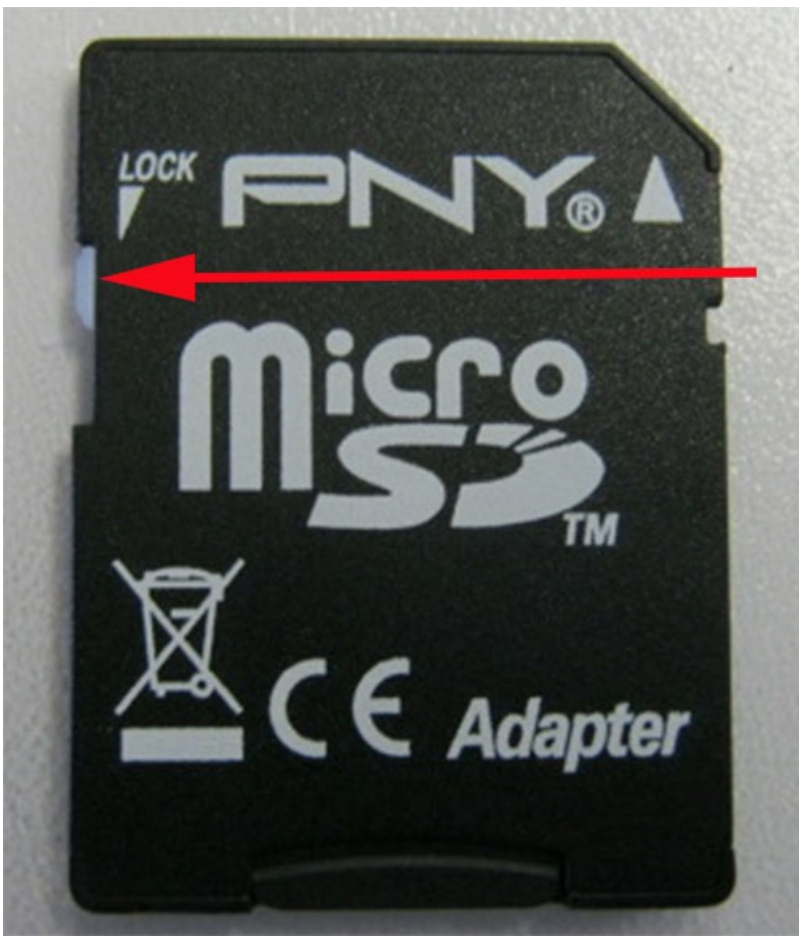
If the vehicle is intermittently losing connection with the SD card, there may be several possibilities as to why. There may be an issue with the connector at the back of the SD card reader. The USB cable that connects the card reader to the PDR module may be stressed, causing a poor connection at the hub. Also, if there is a self-stick paper label applied to the SD card, this may prevent the SD card from being fully inserted and locked into the card reader. The label may also inadvertently cover the lock tab on the side of the SD card. Both of these instances may cause the card reader to interpret the situation as the SD card itself being locked. This lock tab can be seen in the photo below. Please verify that the "Lock" tab on the SD card is in the unlocked position.

Please try a different, known good SD card before replacing any parts in the PDR system.
