Service Bulletin

File in Section: -
 Bulletin No.: 16-NA-308
 Date: September, 2016

Subject: Preliminary Service Procedure for Water Leak Around Rear Window, Water Found in Trunk, Possible Malfunction Indicator Lamp (MIL) Illuminated

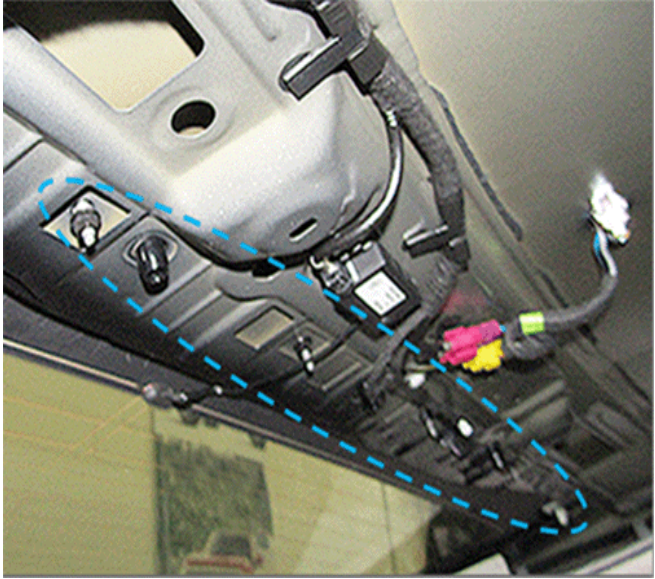
<p style="text-align: right; font-size: small;">4583911</p> <p>The cause of the condition may be loose or missing nuts retaining the Center High Mounted Stop Lamp (CHMSL), which may allow water to by-pass the CHMSL and flow into the trunk area.</p>
