# Service Bulletin

**Subject:** Door Rattle Noise from Outside of Vehicle During High Radio Volume or High Bass Levels

**Models:** 2014-2016 Chevrolet Corvette

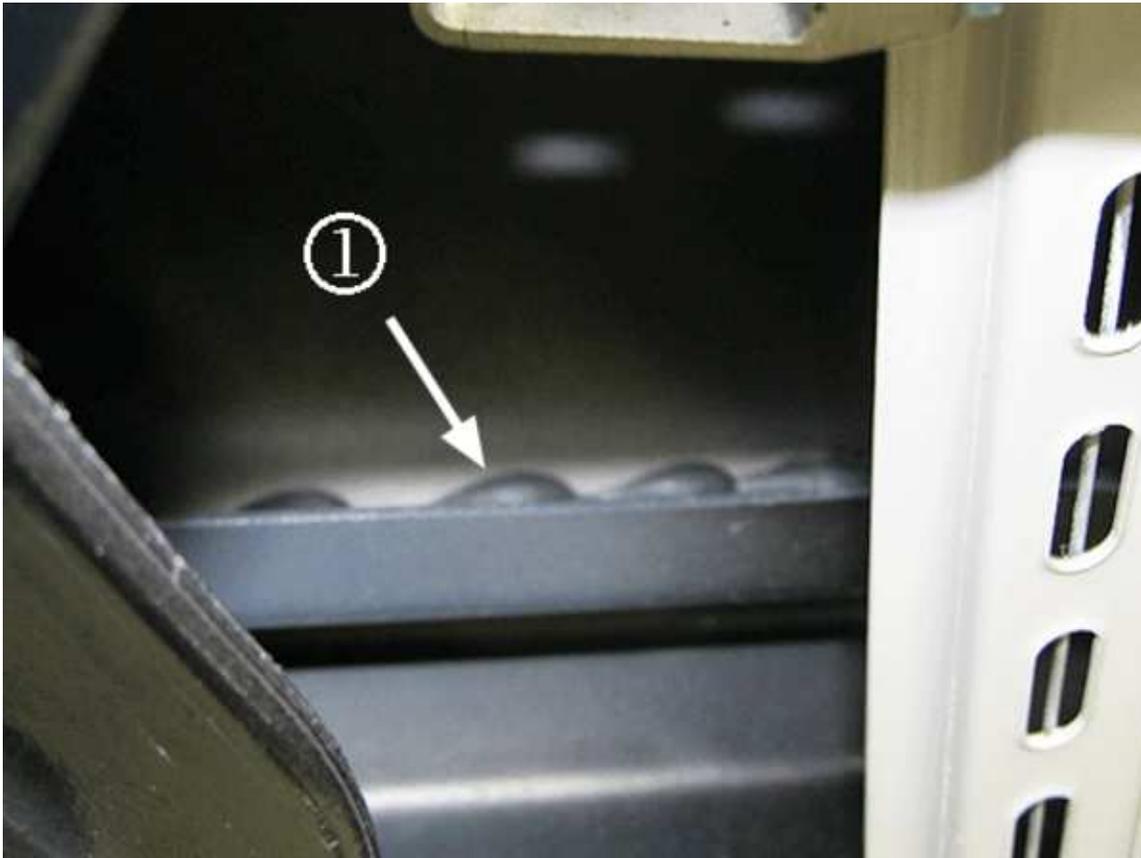
The cause of this condition may be voids in adhesive (1), leaving gaps between the inner door beam and the door skin.

Inspect the front side door beam and door skin gap for voids and add a bead of butyl ribbon sealer in those areas following the steps below:

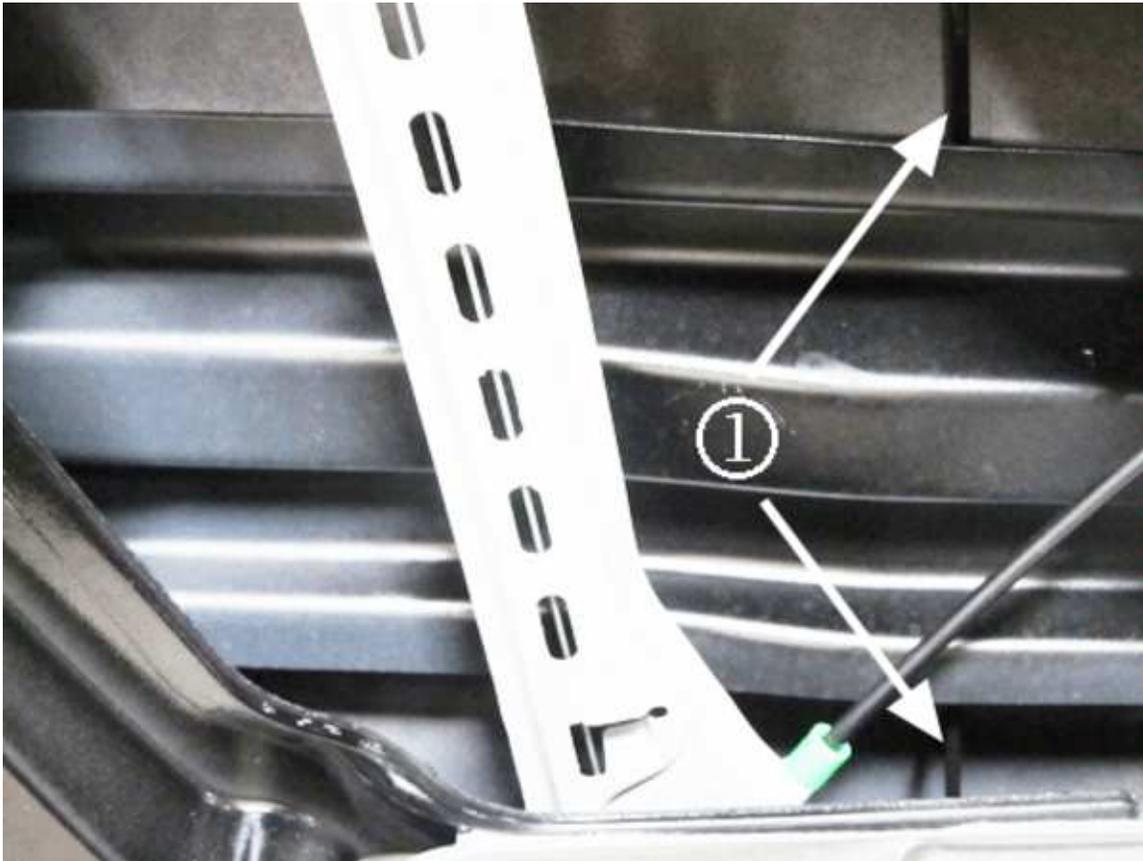
The graphic above shows an example in which a tie strap (1) was passed through a 15-20 cm (6-8 in) length gap where the adhesive was missing towards the center of the door.

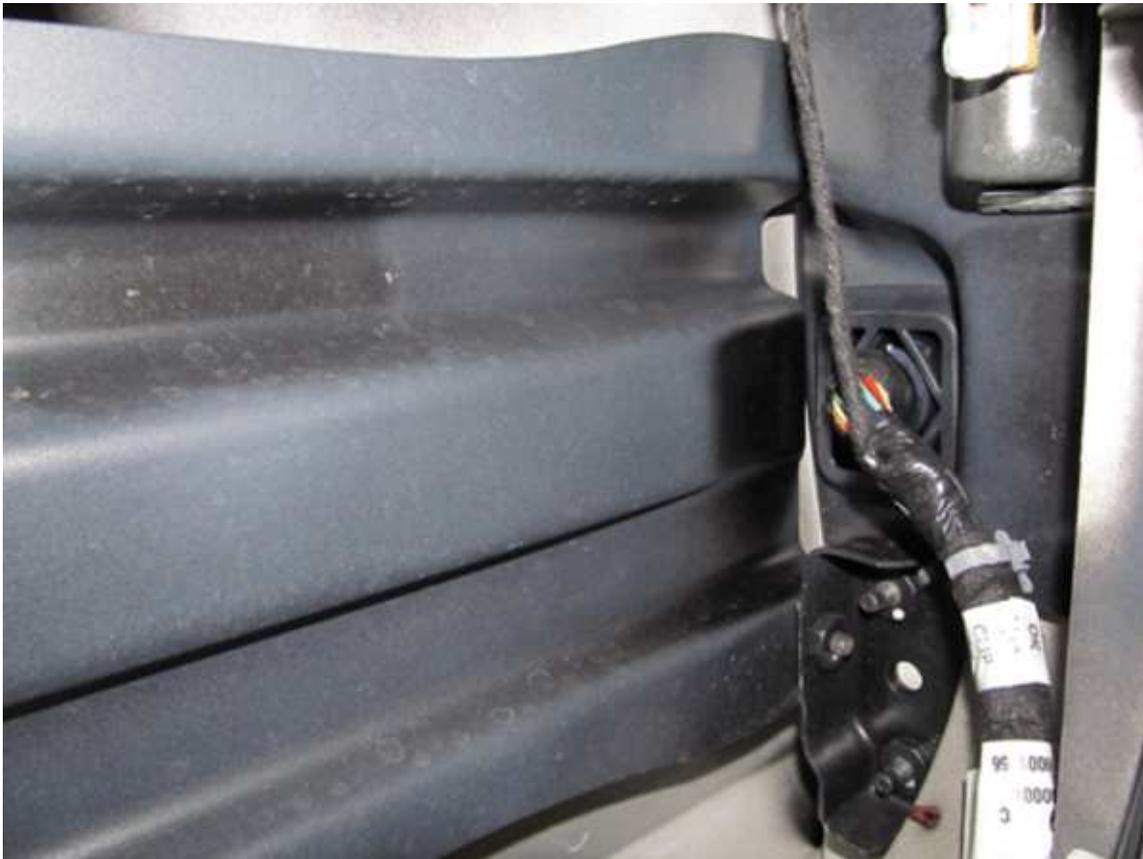
This can also occur in the front and/or rear area of the door beam; with the condition sometimes more evident in the front area (shown above) where the radio speaker is mounted.
