**NUMBER:** 08-093-17

Radio Enhancements

This bulletin involves inspecting and if required, updating the radio software.

2017 - 2018                      (MP)                      Jeep Compass

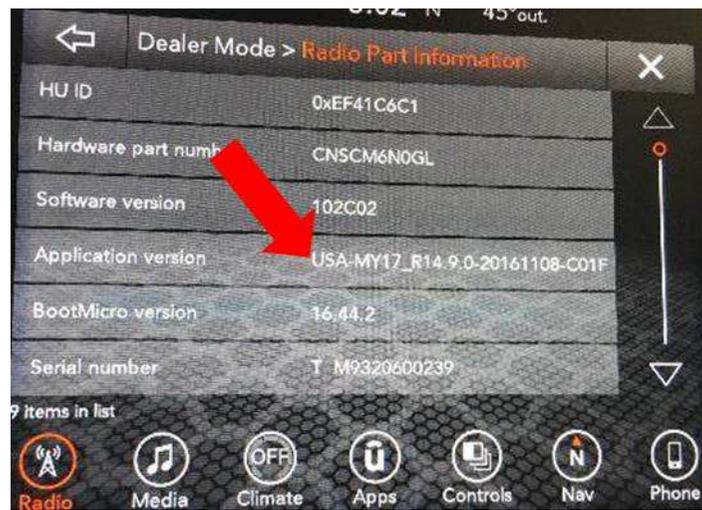
Fig. 1

1. Verify the radio software version. Radio must be in Dealer Mode to verify by following these steps:
  - a. Push and hold the Front Defrost, Driver Temperature Up and Temperature Down buttons simultaneously until the Dealer Mode screen appears (approximately seven seconds). Release buttons.
  - b. Select "Radio Part Information". The software version will be listed next to "Application Version".
2. Is the radio currently at software level 18.7 or higher (Fig. 1) ?
  - YES >>> The radio software is already up to date. Use inspection LOP (18-60-02-PF) to close the active RRT.
  - NO >>> The radio software needs to be updated. Back out of Dealer Mode and proceed to [Step 1](#) of the Repair Procedure.

Radio Software Level Screen

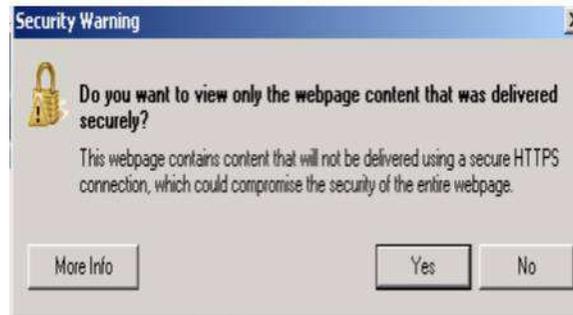
Fig. 2  
Pop-Up Security Message

3. If a security message appears “Do you want to view only the web page content that was delivered securely?” (Fig. 2) . Press “No” to continue.

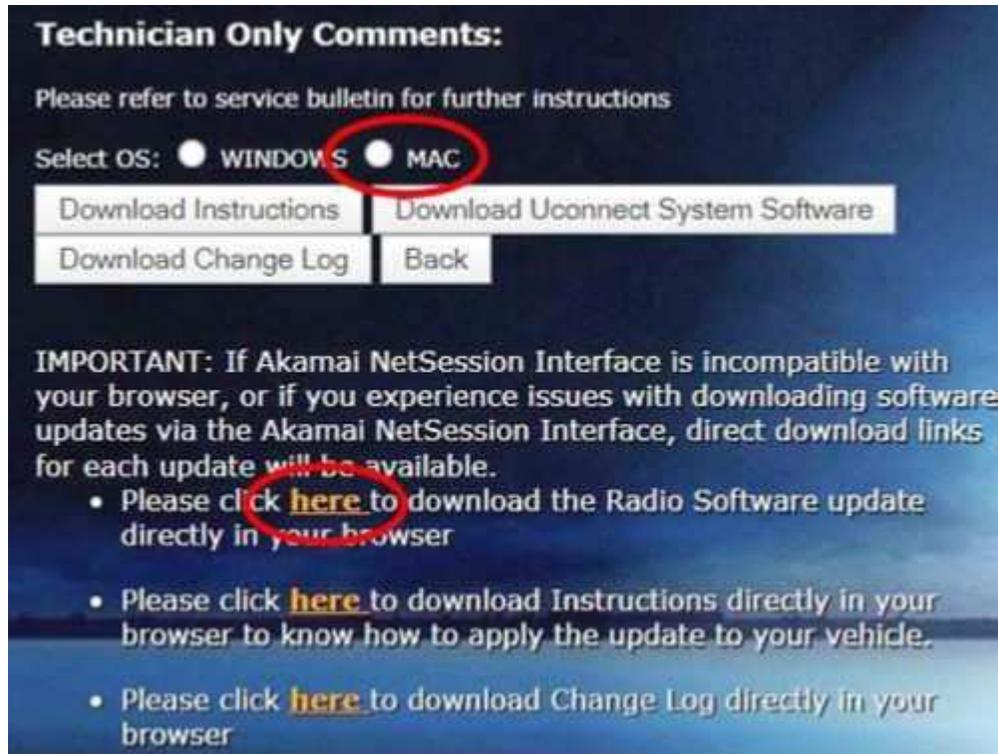
Fig. 3

## MAC Download Steps

5. Make sure to select the “MAC” radial button for all downloads (Fig. 3) .
6. Download the software update file to your local PC’s desktop, then download the file to your designated folder (Fig. 3) before extracting the zip file to the blank USB flash drive.

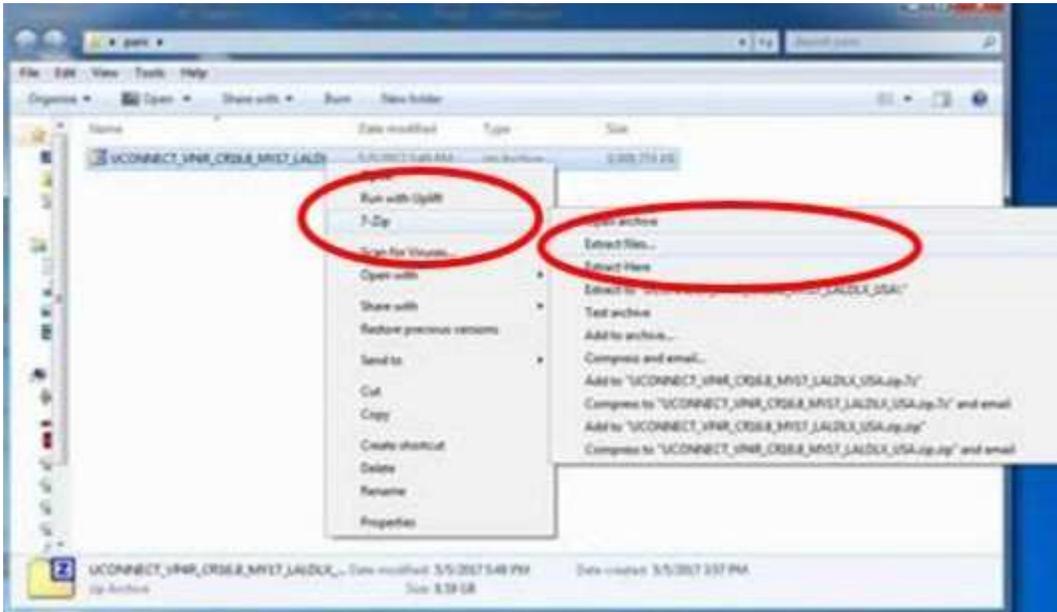
Fig. 4  
Zip File Extraction

7. Extract the downloaded zip file to the designated USB flash drive (Fig. 4) and (Fig. 5) .  
**NOTE: It may take a few minutes for an accurate extract time to be displayed.**

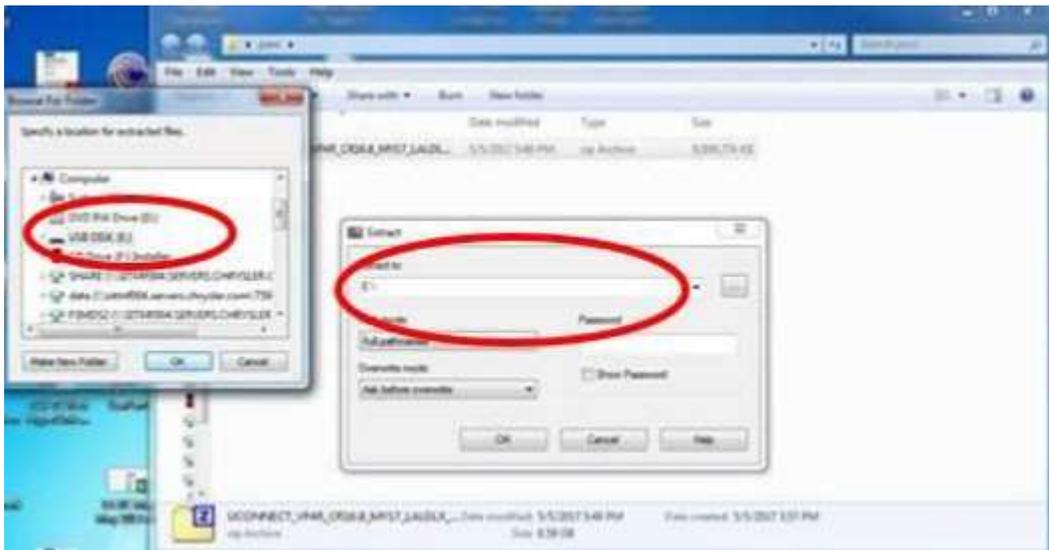
Fig. 5  
Saving File To USB

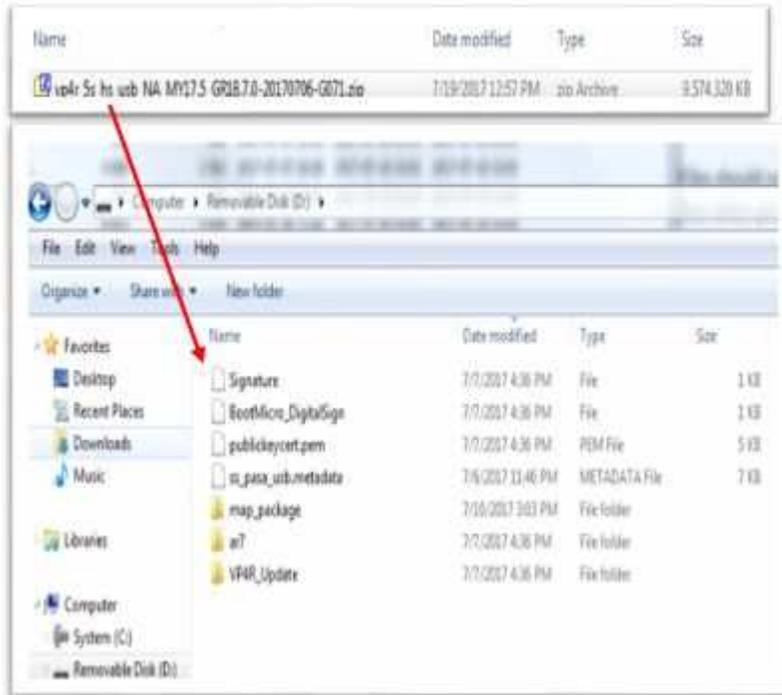
**Fig. 6**

**NOTE:** Make sure all files and folders are copied to the USB flash drive (Fig. 6) . Failure to do so may cause the navigation feature not to work properly and the radio may need to be replaced.

**All Files/Folders Must Be On USB Flash Drive**

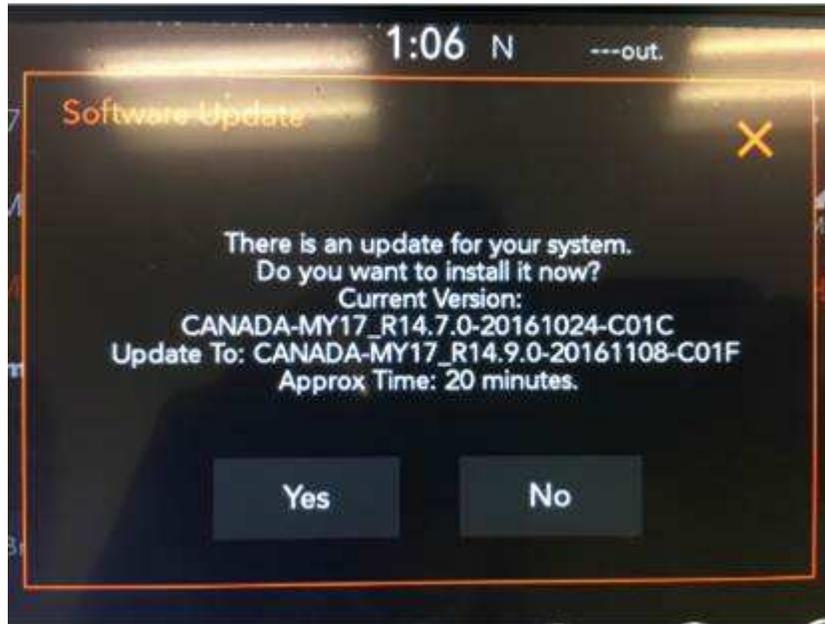
Fig. 7

Software Levels (The figure is for reference only, actual software levels will be 16.8 to 18.7)

10. The next screen display will have the old and new software levels (Fig. 7) . The radio will be updated to 18.7.

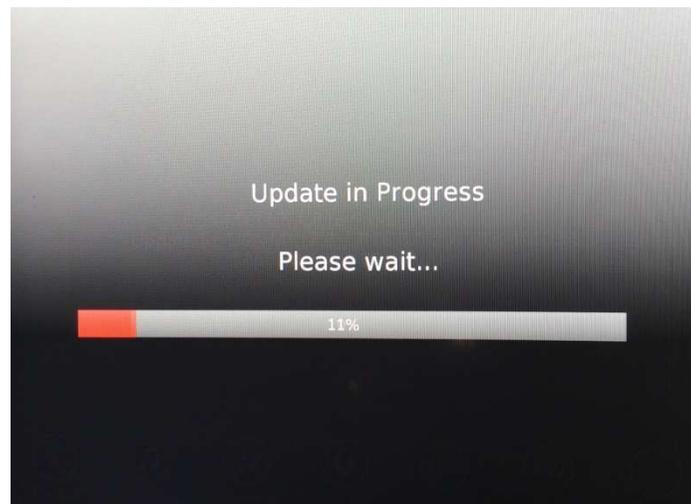
Fig. 8

Update In Progress Screen

11. Press the touchscreen “YES” to start the update. The update may take up to 40 minutes, no other actions are needed to initiate the update (Fig. 8) .

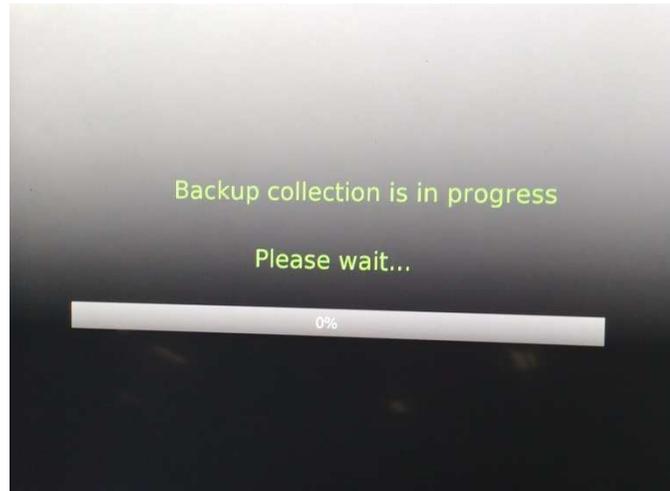
Fig. 9  
Backup Collection Screen

- **DO NOT** cycle the ignition or touch the radio during the update process.
  - If the software update process is interrupted, aborted or failed, the process should be restarted.
12. Once the update process is completed, the Backup Collection screen will appear (Fig. 9) . Backup collection takes about five minutes.

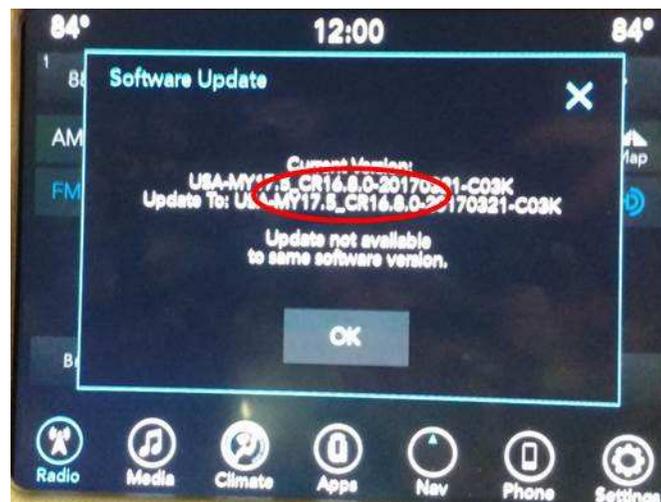
Fig. 10

Software Levels After Radio Restart Screen (The figure is for reference only, actual software levels will be 18.7)

13. After the update is done the screen will display the software levels again and the message that an update is not available to the same software version (Fig. 10) .

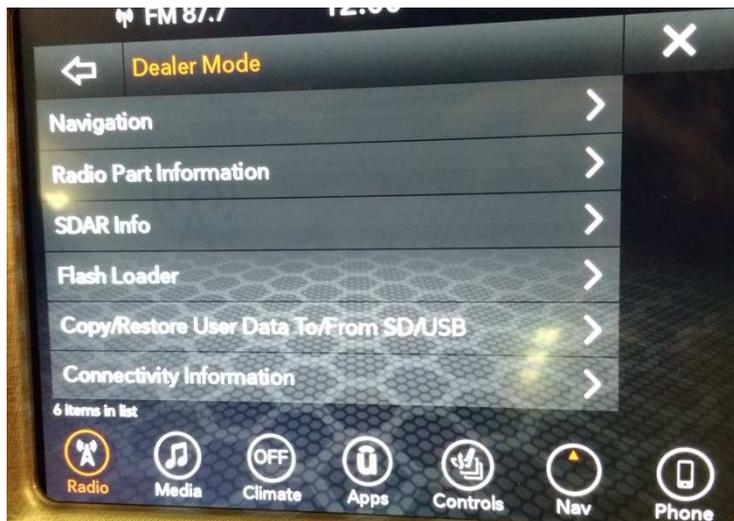
Fig. 11  
Dealer Mode Screen

15. Return to Dealer Mode (Fig. 11) to perform a manual reset and complete the update by following these steps:
  - a. Push and hold the Front Defrost, Driver Temperature Up and Temperature Down buttons simultaneously until the Dealer Mode screen appears (approximately seven seconds).
  - b. Hold the upper right corner of the touchscreen until the radio reboots (approximately ten seconds).
