Preliminary Information

PIP5411F SES light with DTC's P2635 and/or P018B setting in high ambient temperatures

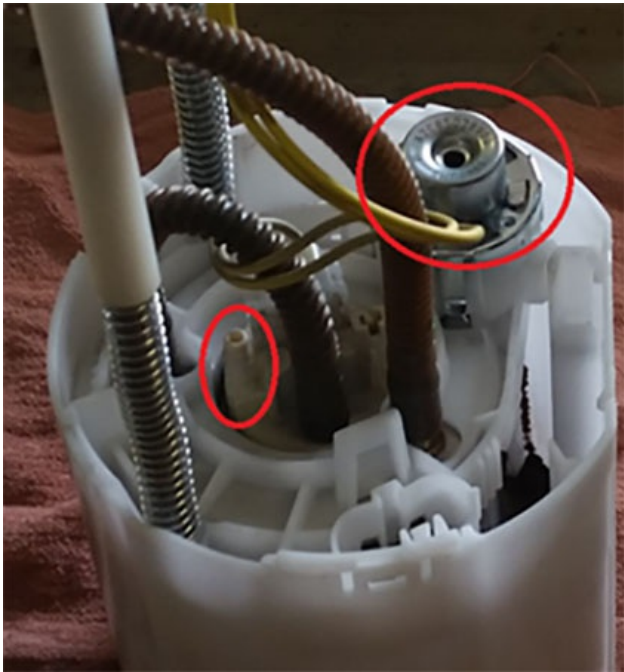
Old design

Brand:	Model:	Model Years:	VIN:		Engine:	Transmissions:
			from	to		
Cadillac	Escalade	2015 - 2016	All	All	6.2L L86	All
Chevrolet	Silverado	2014 - 2017	All	All	4.3L LV3 5.3L L83 6.2 L86	All
Chevrolet	Suburban	2015 - 2016	All	All	5.3L L83	All
Chevrolet	Tahoe	2015 - 2016	All	All	5.3L L83	All
GMC	Sierra	2014 - 2017	All	All	4.3L LV3 5.3L L83 6.2L L86	All
GMC	Yukon	2015 - 2016	All	All	5.3L L83 6.2L L86	All
GMC	Yukon XL	2015 - 2016	All	All	5.3L L83 6.2L L86	All
Involved Region or Country:		North America, Middle East				
Additional RPO/s:		L83 L86 LV3 9C1 FLT				
Condition:		In ambient temperatures 100 F (37.7 C) degrees or higher, DTCs P2635 and/or P018B may set. The vehicle may also exhibit a hesitation or stalling condition.				
Cause:		Vapor buildup in fuel feed line
