Service Bulletin

PRELIMINARY INFORMATION

Subject: Power Liftgate Erratic Operation Will Not Power Close DTC B153A And/Or Motor Running But Does Not Move

Models: 2015 Cadillac Escalade Models
2015 Chevrolet Tahoe, Suburban
2015 GMC Yukon Models

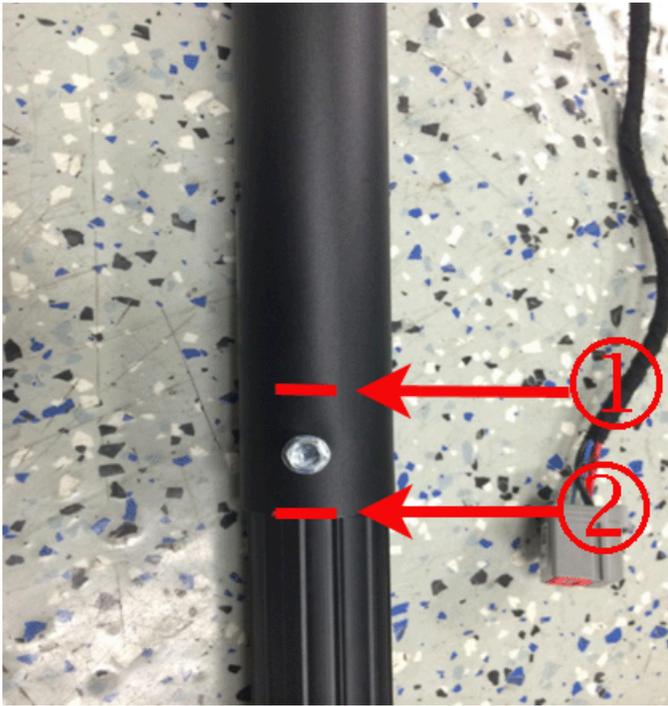
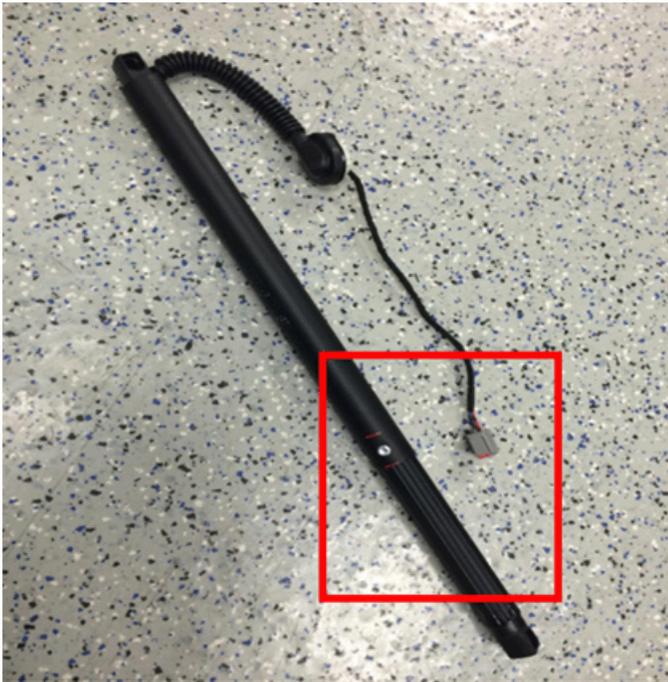
These concerns may occur if the left liftgate strut/motor actuator is internally coming apart. It will need to be replaced, but care must be taken when removing the left liftgate strut/motor actuator from the vehicle. There is an assist spring inside the strut. If the internal portion of the strut has completely separated, and if it is removed from the vehicle without following the procedure listed below, the end of the strut can become a projectile.

1. Obtain one #8 self-tapping screw 1 1/2 inches long.
2. Fully open the liftgate.
3. Install the self-tapping screw any place in the 30 mm space (from the bottom of the smooth tube) between location 1 and 2. As reflected below, a location of 20 mm (approximately 3/4") is ideal to secure the tubes.

Note: The screw will hold the strut together for removal.
