Customer Satisfaction Program

16147 Center High Mount Stop Lamp Water Leak

Reference Number: N162064340

Release Date: December 2016
Revision: 00

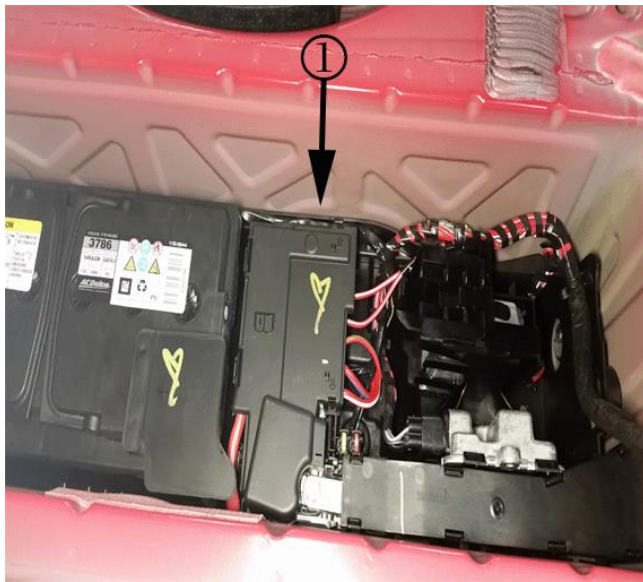
4641354

3. Inspect the battery tub (1) for the evidence of a water leak or standing water.
 - If evidence of a water leak or standing water is NOT found, proceed to step 14.
 - If evidence of a water leak or standing water is found, proceed to the next step.

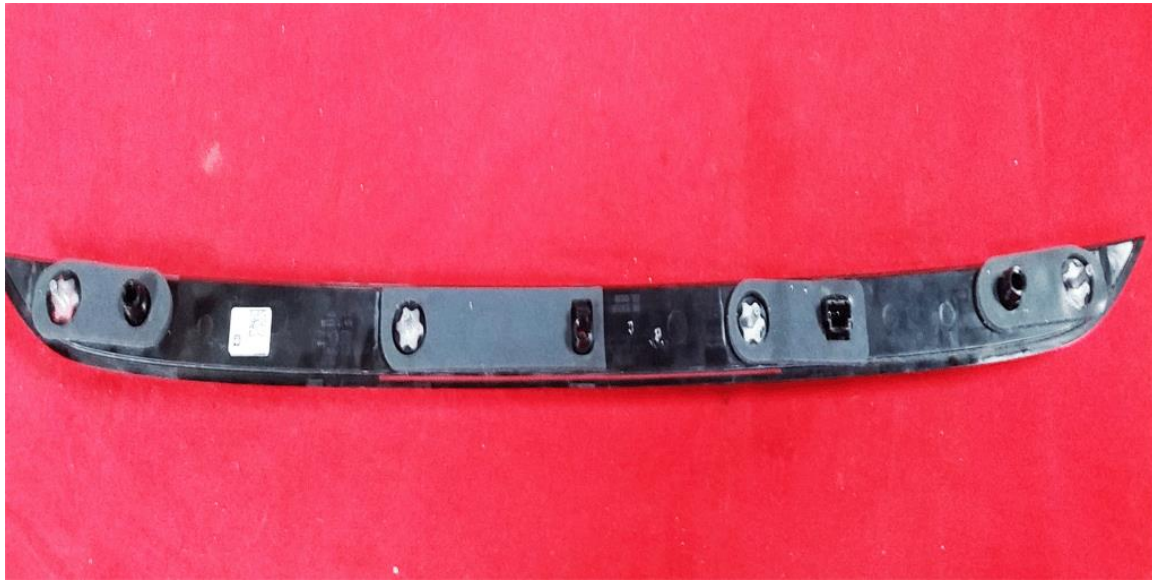
4641389

Caution: Make sure the gasket is centered and does NOT ride up the fastener joint. A water leak may occur if the gasket is not installed properly. Refer to the pictures above.

28. Install NEW gaskets on the high mount stop lamp.
