Service Update

17107 Rear Back Glass Water Leak

Reference Number: N162078080

Release Date: March 2017
Revision: 00

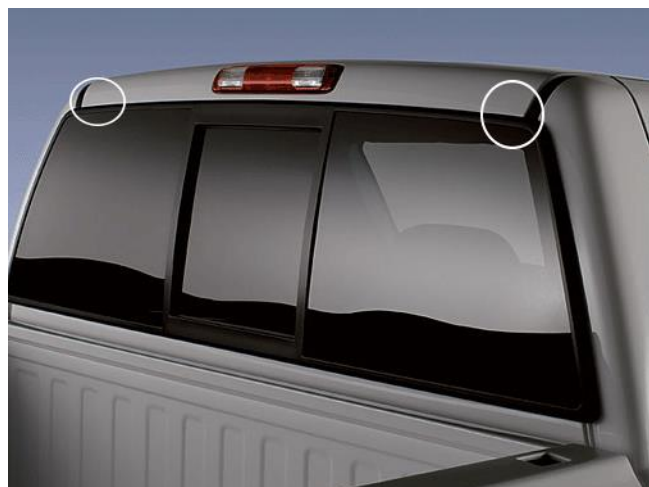
4756485

Condition	Certain 2017 model year Chevrolet Colorado and GMC Canyon vehicles with a sliding rear window may have a small hole in the casing surrounding the glass. Customers may experience water intrusion into the rear passenger compartment, and the seats or trim may get wet.
Correction	Dealers are to apply seam sealer to cover the small hole in the casing.
