# Service Bulletin

**Subject:** Information on Changes to SPS that Warn/Prohibit Reprogramming a Module With its Current Calibration

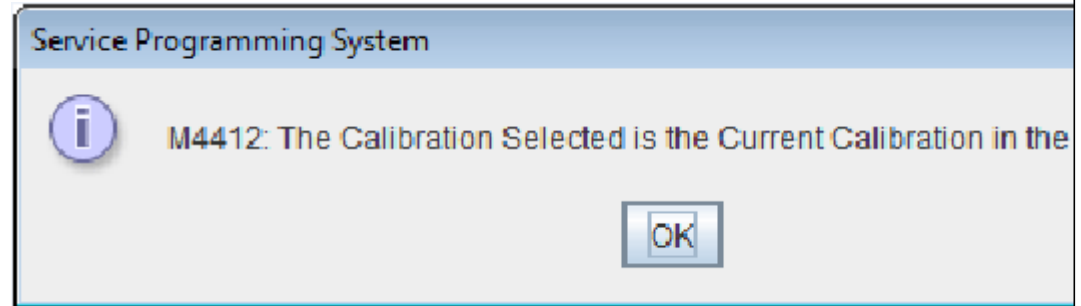
- Programming a control module with the salemarks Chevrolet (GM Korea) and Chevrolet (Holden) and with the same calibration already in the module, will be prohibited. If you attempt to reprogram a module with its current calibration you will be prompted with the above warning message. You will not be allowed to redundantly reprogram the module. This message does Not indicate an issue with the module in question - pursue SI diagnostics for further root cause determination.

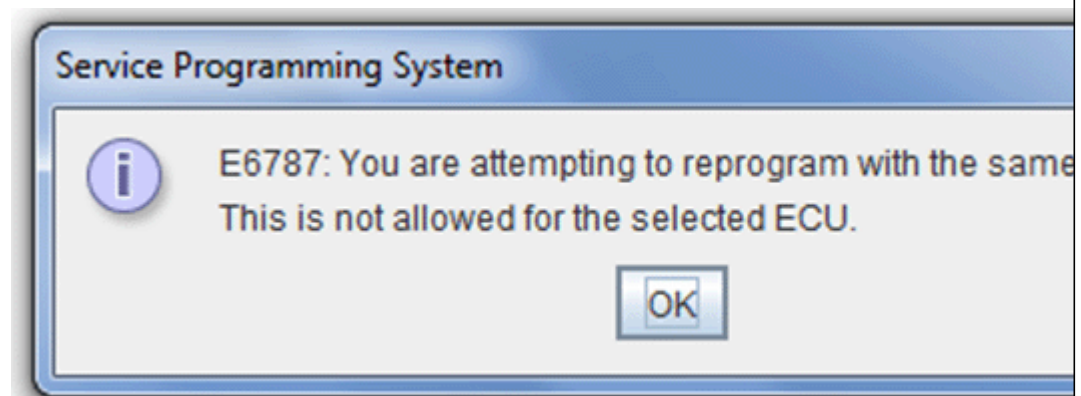
- **Model Year 2017 and Newer:** Programming a control module with the same calibration already in the module will be prohibited. If you attempt to reprogram a module with its current calibration you will be prompted with the above warning message. You will not be allowed to redundantly reprogram the module. This message does Not indicate an issue with the module in question - pursue SI diagnostics for further root cause determination.

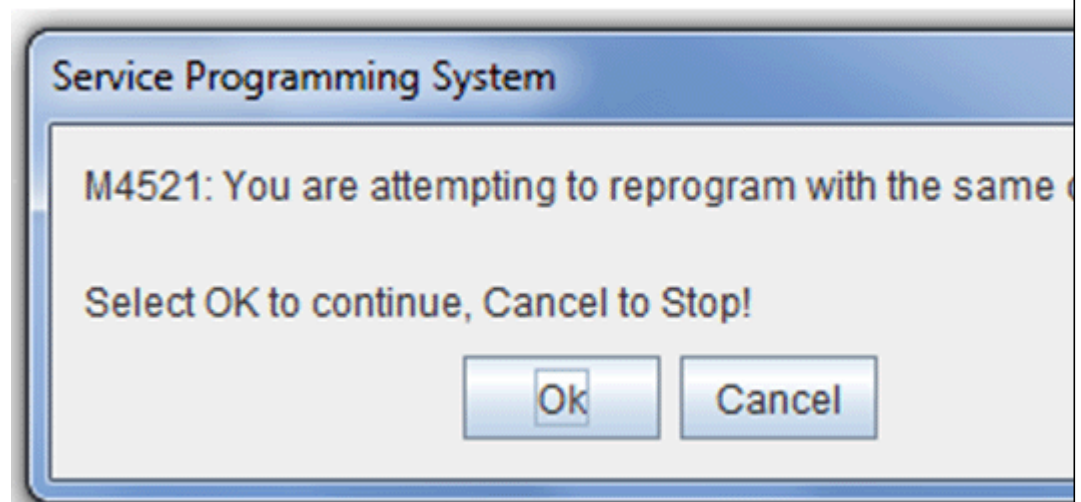
- **Model Year 2016 and Older:** If you attempt to reprogram a module with its current calibration, you will be prompted with the above warning message. This message does Not indicate an issue with the module in question - pursue SI diagnostics for further root cause determination.

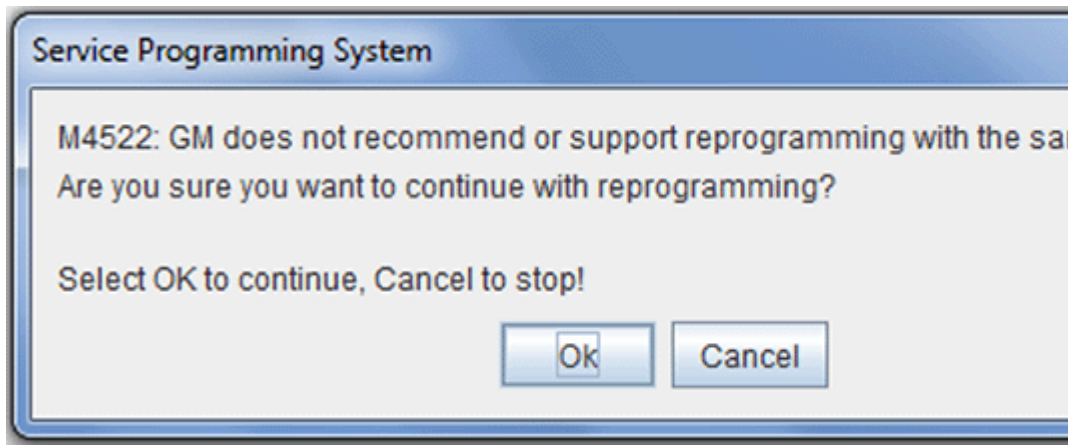
- You are not required to hit cancel, you can click OK to continue with the reprogramming. If you click "OK" on the above warning you will be prompted with a second notice.
- As stated, it is not supported or recommended to reprogram the same module with its current calibration, however you can proceed with the reprogramming even by clicking "OK" on the above warning message.
