Special Coverage Adjustment

38170 Accelerator Pedal Stalk Fracture

Reference Number: N16203817
GWM Number: 2038170

Release Date: August 2016
Revision: 00

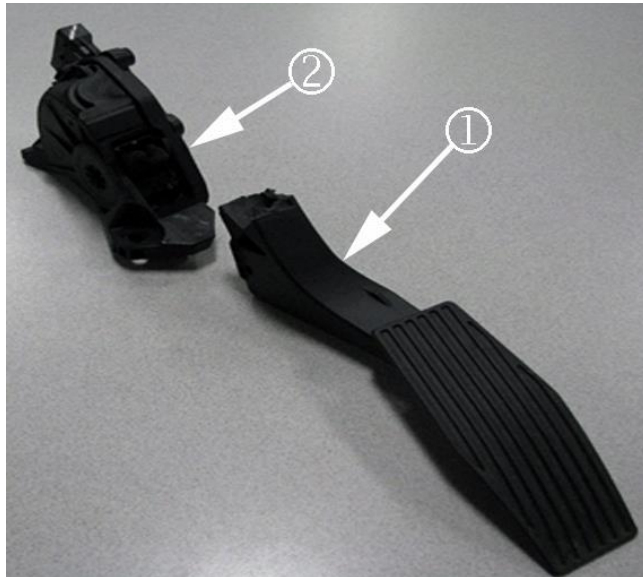
4570113

1. Verify that the accelerator pedal (1) has separated from the housing (2).
 - If the accelerator pedal is NOT separated from the housing, no further action is required. Inform the customer that any additional diagnosis and repairs are not covered under this special coverage.

If the accelerator pedal is separated from the housing, replace the accelerator pedal. Refer to *Accelerator Pedal Position Sensor Replacement* or *Accelerator Pedal Replacement* in SI.
