Service Bulletin

PRELIMINARY INFORMATION

Subject: Loss of Power Steering Assist, Hard to Steer, and/or Service Power Steering Message on DIC

Models: 2012-2015 Buick Verano
2013-2016 Buick LaCrosse Equipped with NJ1
2013-2016 Buick Regal Equipped with NJ1
2014-2016 Cadillac ELR
2010-2016 Chevrolet Equinox
2011-2015 Chevrolet Cruze, Volt
2013-2015 Chevrolet Malibu
2016 Chevrolet Malibu Limited
2014-2016 Chevrolet Impala (VIN 1) Equipped with NJ1
2010-2016 GMC Terrain

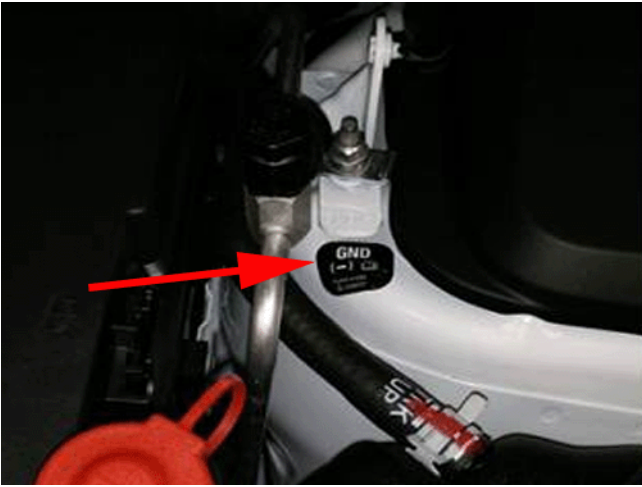
Some customers may comment on loss of power steering assist, hard to steer, and/or Service Power Steering message on DIC.

This may be caused by a blown/failed power steering fuse, which could be a result from improper jump starting.

1. Locate the power steering fuse.
2. Check to determine if the fuse is open. To do so, check for continuity using a Digital Multimeter (EL-39200) or a continuity tester.
3. If the fuse element is broken, replace the fuse.

Important: When installing the new fuse, tighten the fasteners to 5 Y (44 lb in).

4. After fuse is replaced, install an electrical ground point label, GM P/N 10384767, in the approximate location as illustrated above.
