Service Bulletin

PRELIMINARY INFORMATION

Subject: Service ABS / TCS / Power Steering and/or Suspension Message DTC U0077 U0121 U0126 U0131 U0139 U0401 U0415 U0428 (Circuit 5986 High Resistance)

Models: 2015 Cadillac Escalade Models
2014 Chevrolet Silverado 1500
2015 Chevrolet Silverado, Suburban, Tahoe
2014 GMC Sierra 1500
2015 GMC Sierra, Yukon Models

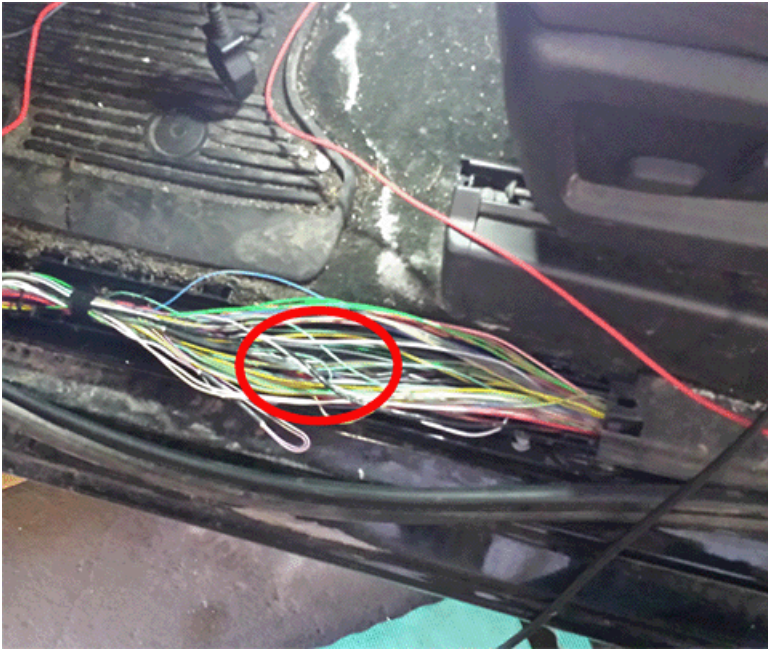
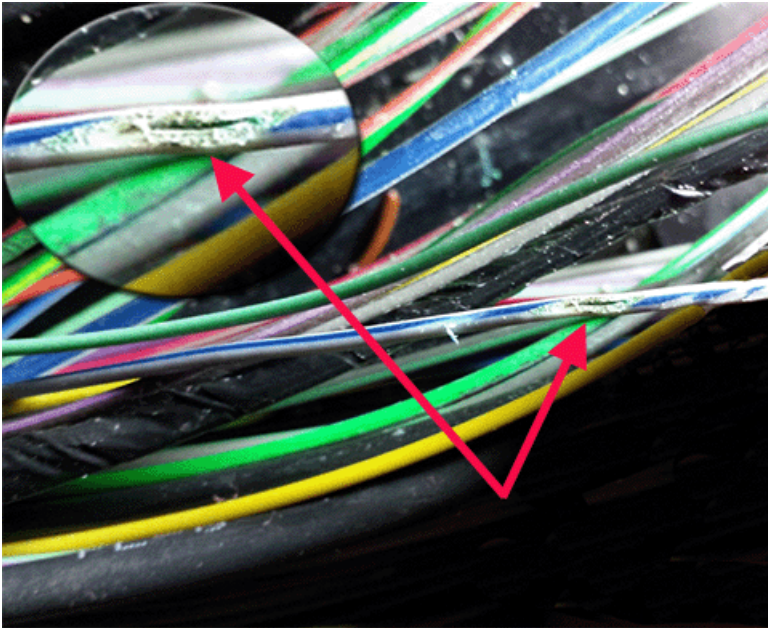
These concerns could be caused by high resistance/open in the Communication Enable circuit 5986. The BCM activates this circuit when the ignition key is in ACC, ON, and START positions (There will be voltage present in the OFF position only for a short time until the BCM goes to sleep). The communication enable circuit wakes up the module for serial data bus communication. Circuit 5986 will have approximately 12 volts and should light a test light, but is not designed to handle heavier electrical loads like a headlight bulb. Shown below are two known areas where circuit 5986 has been found to be open or have high resistance:

1. Under the driver's sill plate
2. Splice J365 located under the passenger front sill plate

Monitor the voltage on the communication enable circuit 5986 at any of the modules affected, example EBCM, PSCM, and/or SCM. If low voltage or no voltage is present when the concern occurs, inspect for high resistance under the driver's or passenger's sill plate area. Repair any opens or high resistance in the circuit.
