Service Bulletin

Subject: Rear Of Engine Oil Leak

Models: 2015 Chevrolet Express, Silverado

Equipped with 6.6L Duramax Diesel Engine RPO codes LGH or LML

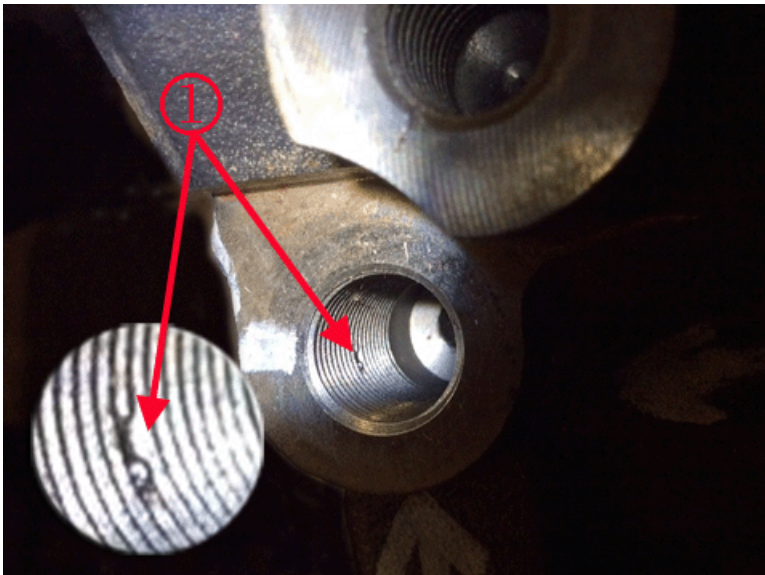
1. Inspect the turbocharger oil feed hole for signs of damage or porosity. Refer to picture below

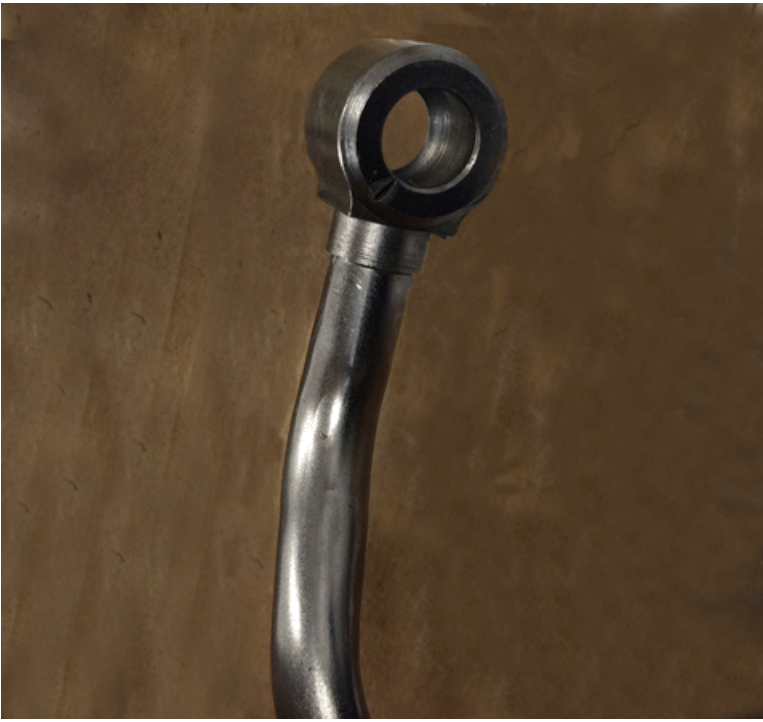
2. Inspect for imperfections in the gasket sealing surfaces (lack of flatness, debris or damage to the feed line banjo fitting itself.)

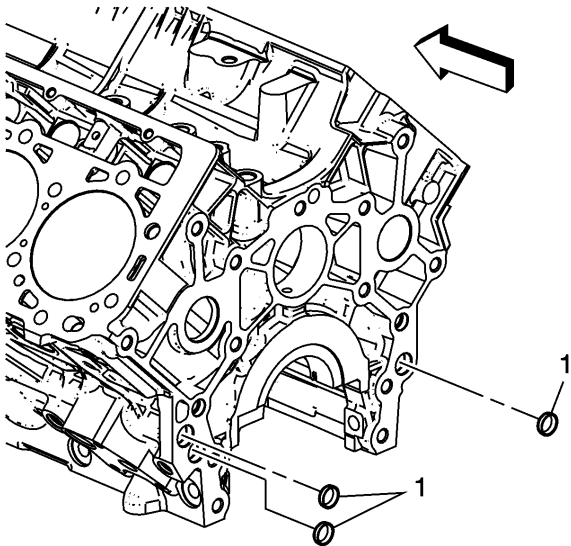
4. Check for leaks at the engine oil cooler. Leaks from the oil cooler can be caused by debris or damage to the oil cooler O-ring.
5. Check for leaks at the engine block oil gallery cup plugs.

There are sub-oil galleries that run the full length of the block on both sides of the engine (same gallery that feeds oil pressure sensor). These galleries end at the rear of the block and are sealed with cup plugs (properly listed and available in GMSPO parts imager). Since these galleries run on either side of the engine this oil leak may be found on the right or left rear of engine. The flywheel housing cover must be removed to service these plugs.

If one oil gallery cup plug is found to be leaking, replace all three (two on the left and one on the right) cup plugs at the same time the flywheel housing is resealed.

When replacing these oil gallery cup plugs use Loctite 272T (or Equivalent) part number 89021297 (in US) or 10953488 (in Canada) as a sealer.

During cup plug replacement ensure at least 1 mm of recess when pressing in the plug.
