# Service Bulletin

Bulletin No.: 17-NA-265

**Subject: Flutter or Thump Noise from Rear of Vehicle**

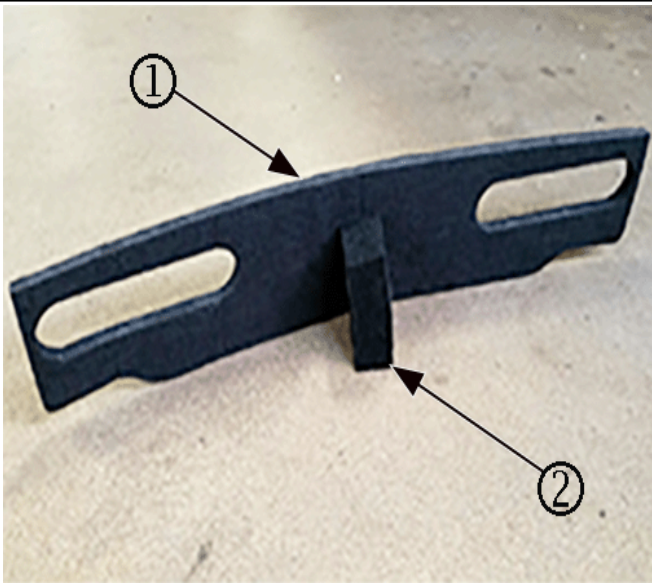
<b>Involved Region or Country</b>	North America and N.A. Export Regions
<b>Condition</b>	Some customers may comment on hearing a flutter or thump noise from the rear of the vehicle. The noise is most noticeable while driving above 40 km/h (25 mph), with the HVAC off, or in recirculation mode.
<b>Cause</b>	The cause of the condition may be the rear pressure relief valves (PRVs) opening and closing.
<b>Correction</b>	<div style="text-align: center;">
