Service Bulletin

Subject: Service StabiliTrak or Antilock Brake System Warning Lamp Illuminated

Models: 2013 Chevrolet Equinox
2013 GMC Terrain
All Built Prior to February 26, 2013

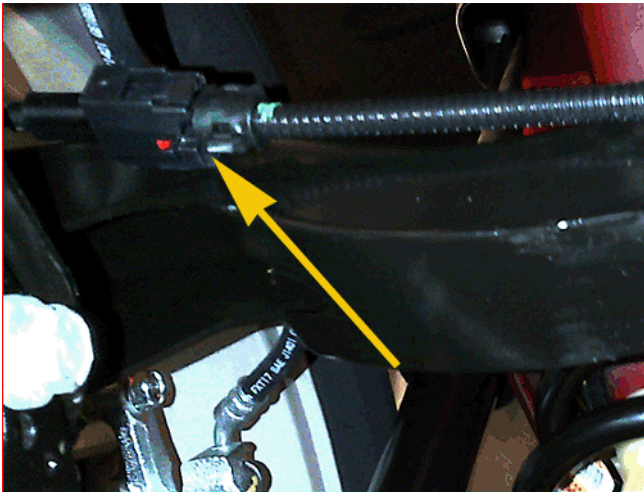
Some customers may comment that the Service StabiliTrak and/or Antilock Brake System Warning lamp(s) are illuminated. This may be an intermittent condition. When diagnosing the vehicle, the technician may find DTC C0045 Left Rear Wheel Speed Sensor Signal or C0050 Right Rear Wheel Speed Sensor Signal set.

This condition may be caused by one or both of the rear wheel speed sensor (WSS) harness terminal(s) or connector(s) not being fully seated (connected).

Important: Do not attempt to re-seat the terminal into the connector. This will not be a permanent repair. If the terminal is out of position or not locked into the connector, the connector must be replaced.

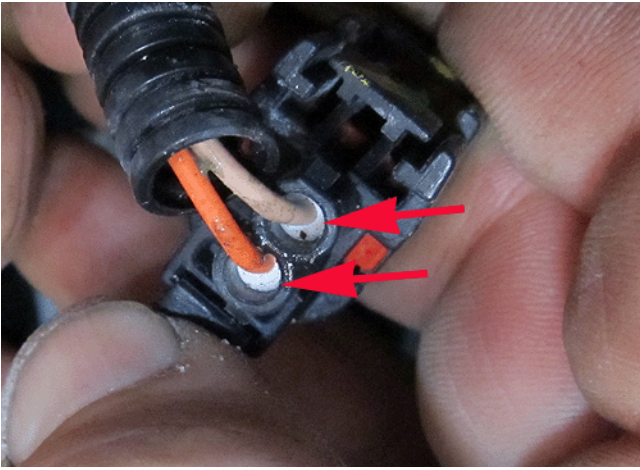
5. Inspect the wire side of the connector and ensure the grommets are fully seated in the connector.

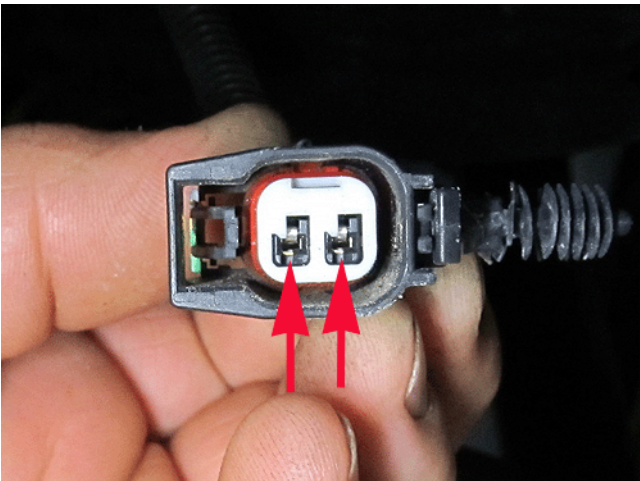
6. Inspect the terminals and ensure they are not damaged or pushing out of position in the connector.
