# Service Bulletin

**Subject:** Convertible Top Difficult to Latch Closed

**Models:** 2013-2014 Chevrolet Camaro Convertible

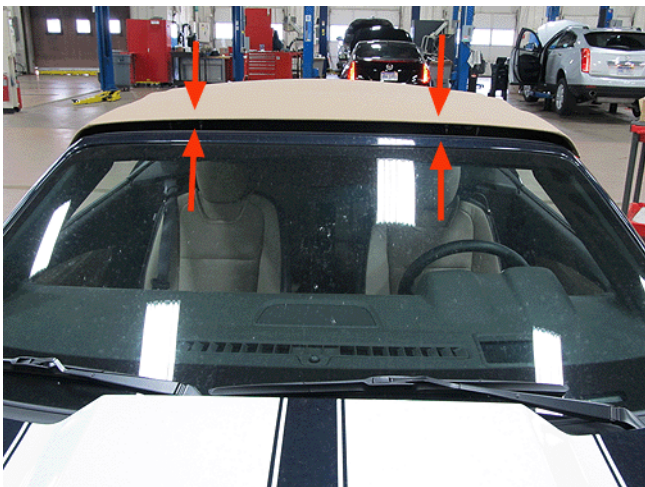
Commonly, when not latched at the header, the top will still show a uniform gap across the top of the windshield.

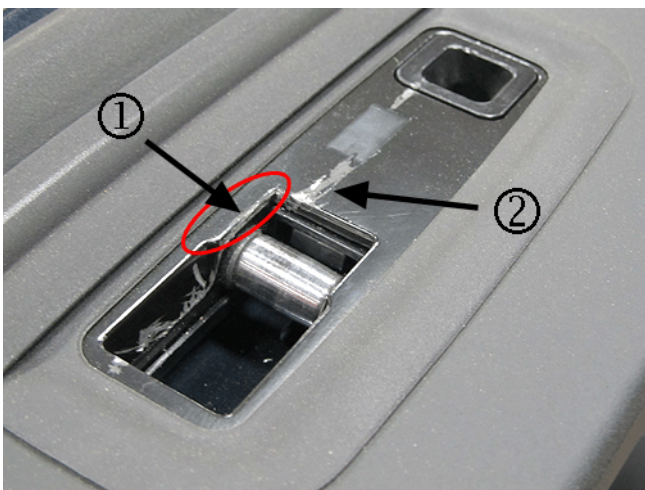
This driver side front striker shows latch impact marks at the forward edge (1) and the latch hook wear marks (2) too far forward.

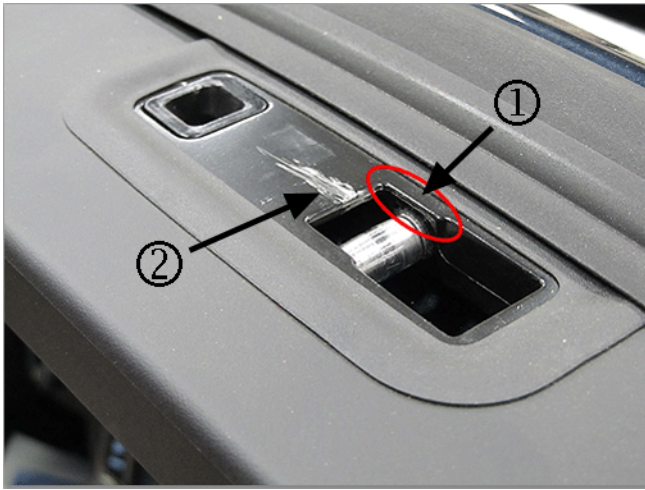
This passenger side front striker shows no indication of latch impact marks (1) and the latch hook wear marks (2) are more centered to the opening.
