# Service Bulletin

Bulletin No.: PI0962B

Date: April, 2014

**Subject:** Radio Resets, Navigation Inoperative, Map Not Displayed, DVD Will Not Play or Resume, Bluetooth® Inoperable, Radio Lockup, Voice Recognition Cuts Off, USB Source not Returning to Last Song, OnStar® Default Volume Low

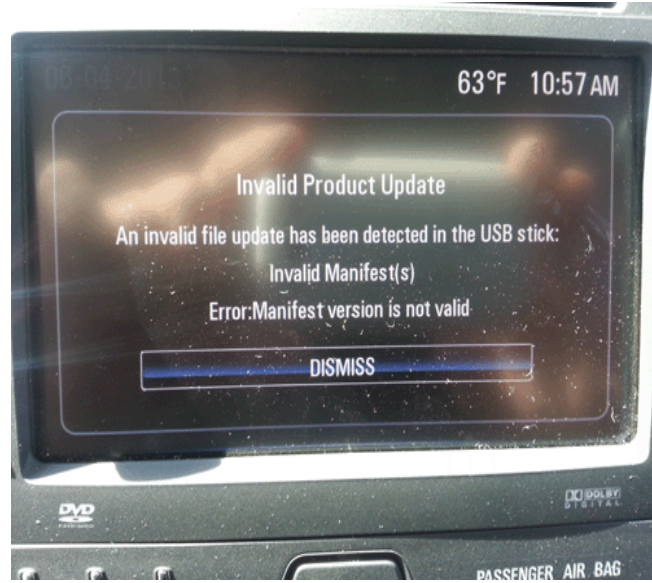
3462549

**Note:** If the following screen above is shown on the screen, the radio already has the latest calibration installed and no further action is required.
