Service Bulletin

PRELIMINARY INFORMATION

Subject: Vibration During Active Fuel Management V4 Mode Operation 1200 – 1400 Engine RPM

Models: 2014-2015 Chevrolet Silverado
2014-2015 GMC Sierra
equipped with 4.3L RPO LV3

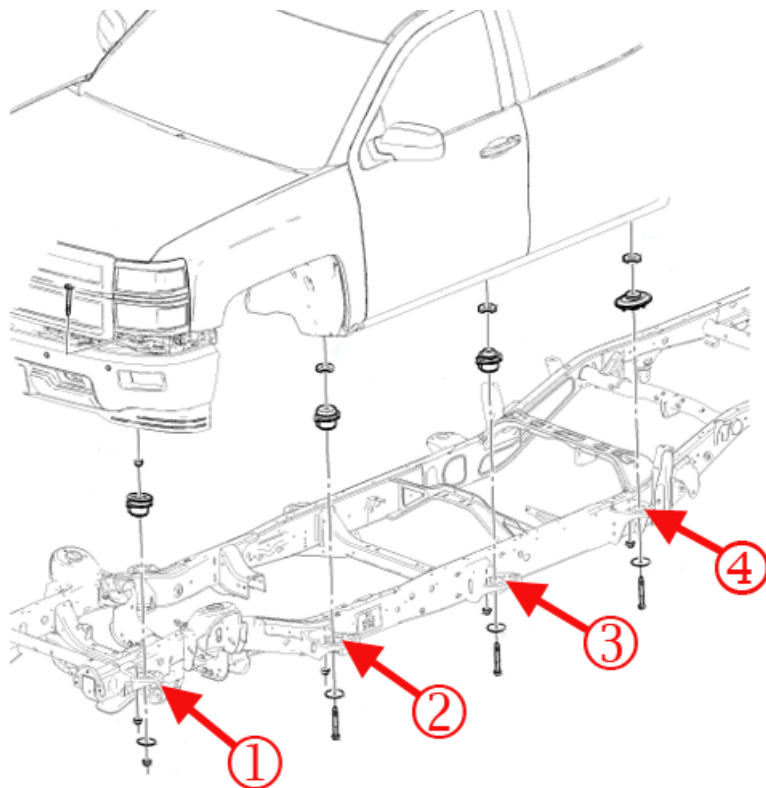
The cab / body mount position locations

The numbers in the picture below indicate the specific mount position. The mounts on the passenger side of the vehicle are identified the same way. This will assist the technician to identify the correct location of each mount so they can be torque to the proper specification.

1 = body mount cushion front

2 = body mount cushion position number 1

3 = body mount cushion position number 2

4 = body mount cushion position number 3

The technician should first loosen the fastener located at the center of each body mount (6 for a regular cab, 8 for crew and double cab).

Using a large angled pry bar, lift up the cab body slightly to settle / relax it. Perform this at each mount location one at a time.

Repeat this cab mount settling process twice, to confirm the mounts are settled / relaxed.

Visually verify that the cab to box alignment is correct before re-torquing all mounts to specification found in Service Information, body repair, frame and under body section.
