TECHNICAL SERVICE BULLETIN

Exhaust Odor In Vehicle

18-2057

Ford 2015-2018 Edge
Lincoln 2016-2018 MKX

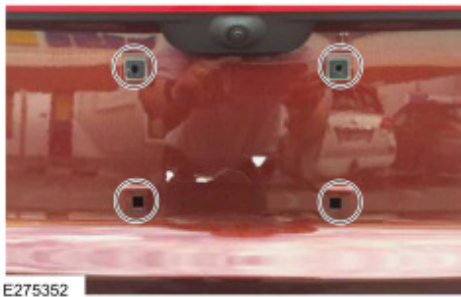
Figure 8

(1). Example of missing lower anchor points. (Figure 8)

12. Inspect the rear liftgate and verify that all four plastic license plate anchor points are sealed.
