TECHNICAL SERVICE BULLETIN

18-2084

Long Wheelbase - 60/40 Left Side Second Row Seat Stuck Or Difficult To Fold/Unfold - Built On 9-Jan-2013 And Through 5-Jan-2018

Ford 2013-2018 Transit Connect/Tourneo Connect
--

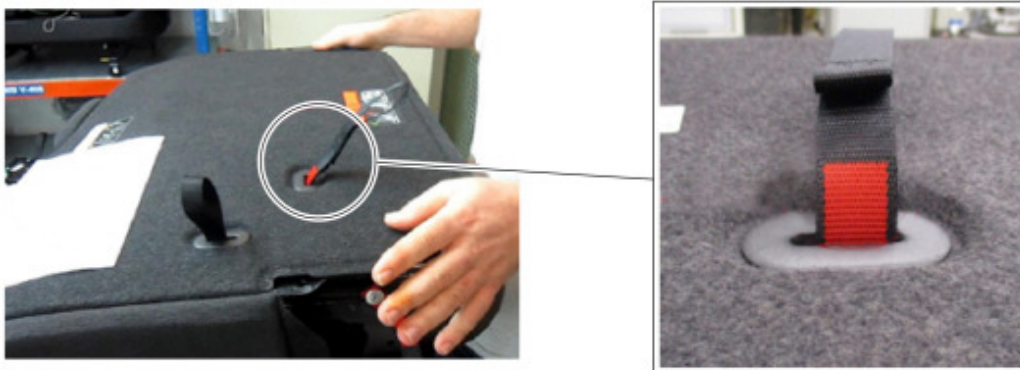
Figure 1

1. Check the vehicle build date. Was the vehicle built on 1–Jan–2013 and through 5–Jan–2018?
 - (1). Yes – proceed to Step 2.
 - (2). No – this article does not apply. Refer to Workshop Manual (WSM), Section 501-10B for normal diagnostics.
2. Is the second row seat bottom on the left side of the vehicle stuck in the folded position and/or is the strap stuck and displaying the red in indicator on the strap on the seat back? (Figure 1)
 - (1). Yes - proceed to Step 3.
 - (2). No – this article does not apply. Refer to WSM for normal diagnosis.

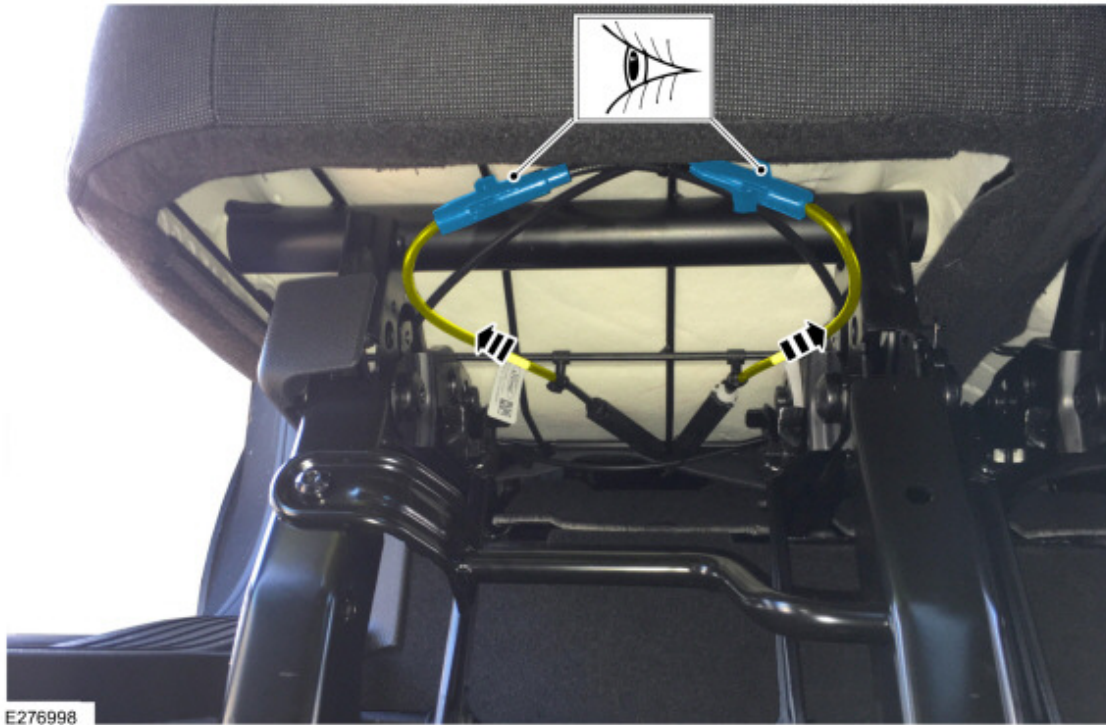
Figure 4

4. Verify the cables are routed correctly. Check for broken retainers. If a retainer is broken then replace as needed. Is the concern still present? (Figure 4)

3. With the help of an assistant, softly pull/wiggle the adjuster cable(s) underneath the effected seat, while a second technician applies downward pressure to the seat back while pulling on the strap. (Figures 2 - 5)
 - (1). Make sure the driver's seat is adjusted to the most forward position. Make sure the second row head rests are in the most downward position.
 - (2). The seat back will not fold up when the seat bottom is stuck.

- (1). Open one adjuster flap by pressing on the adjuster housing. Repeat this for the opposite adjuster flap.
- (2). Pull the cable out of the adjuster to minimize the free play and close the flaps. (Figures 3 - 5)
