**TECHNICAL SERVICE BULLETIN****18-2100****6.7L - Illuminated Malfunction Indicator Lamp (MIL) - DTC U029D And/Or P2209**23 March
2018

Ford 2017 F-Super Duty

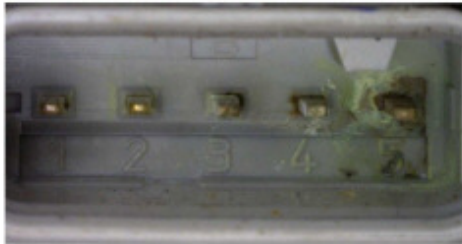
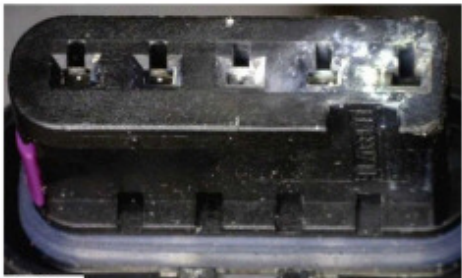
Issue: Some 2017 F-Super Duty vehicles equipped with a 6.7L engine may exhibit an illuminated MIL with diagnostic trouble code (DTC) U029D and/or P2209 in the powertrain control module (PCM). This may be due to water intrusion.

2. Disconnect the nitrogen oxides (NOx) sensor module 11 and inspect for moisture or corrosion on the pins of the harness and module. Is there any sign of moisture or corrosion present? (Figures 1 - 2)

(1). Yes - replace the NOx sensor module 11. Refer to Workshop Manual (WSM), Section 303-14. Proceed to Step 3.
