# Service Bulletin

**Subject:** GM of Canada OnStar® Cellular Communication Upgrade

**Models:** 2000-2014 GM Passenger Cars and Light Duty Trucks  
2015 Buick Enclave  
2015 Cadillac Escalade Models (Built W/O VV4)  
2015 Chevrolet Camaro, Express, Traverse  
2015 Chevrolet Silverado 2500/3500, Suburban, Tahoe (Built W/O VV4)  
2012 Chevrolet Colorado  
2015 GMC Acadia, Savana  
2015 GMC Sierra 2500/3500, Yukon Models (Built W/O VV4)  
2012 GMC Canyon  
2005-2010 Pontiac Vibe  
Equipped with OnStar® (RPO UE1)

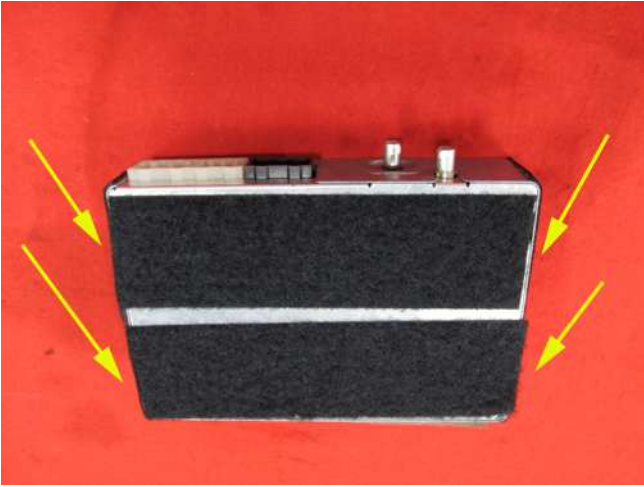
**Note:** After the removal of the original OnStar® module, modification of the new module is required to secure the module into place.

2. Obtain two strips, approximately 177 mm (7 inches) in length, of 2" Velcro® 191195 Reclosable Loop Fastener Tape (hook and loop) or equivalent and apply one side of the tape to the bottom of the module as shown above.

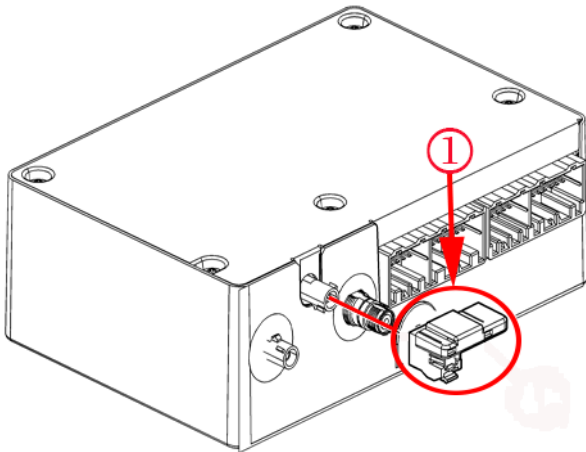
- During the installation of the OnStar® 3G/4G LTE module there may be interference with the module to the bracket not allowing the module to fully seat into place. If this occurs please refer to the “OnStar® Module Bracket Modification” section at the end of this bulletin.
  - Some modules are not as thick as the original modules and require installation of foam to the mounting bracket to prevent movement of the module. Refer to the “OnStar® Bracket Modification” section at the end of this bulletin.
  - For labor time adjustment for the modification, please refer to the “OnStar® Bracket Modification” section at the end of this bulletin for information.
2. If installing the modules P/N 23230482, 23230536, 23230537, 23235220, 23235227, 23235234 and 23383877, transfer the Bluetooth Antenna(1), if equipped, to the new module.

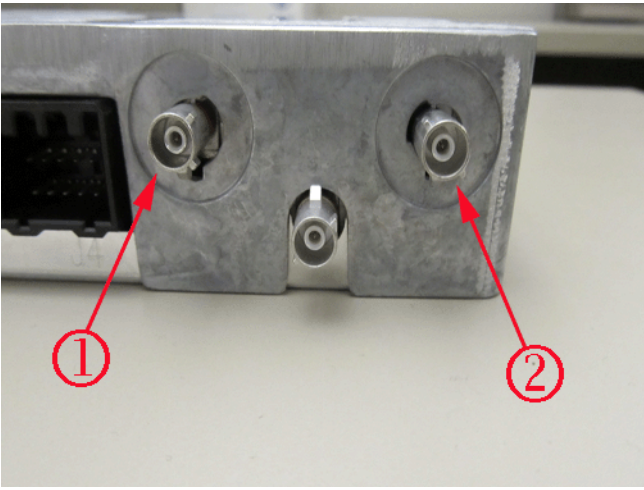
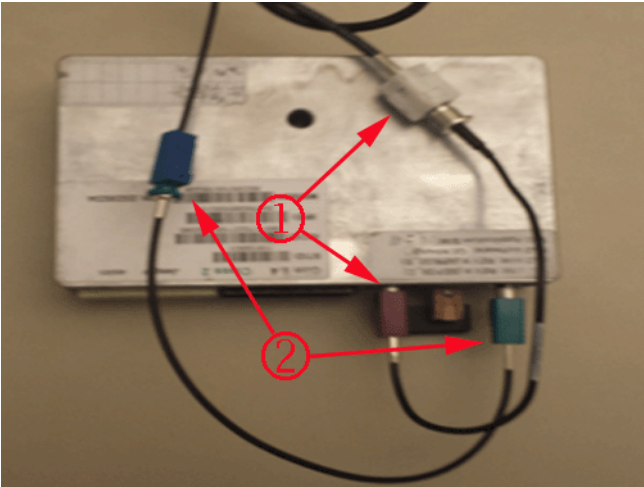
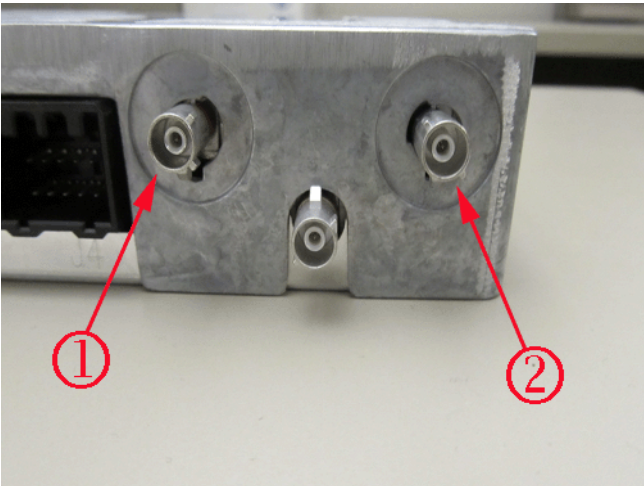
**Note:** The vehicle may have two different configurations, with or without UHF cable. Use the appropriate procedure below:

4. If the vehicle requires a UHF adaptor cable (P/N 23242478) proceed with this step:
  - 4.1. Install the UHF adaptor cable (P/N 23242478) to the antenna connector (1) of the module.
  - 4.2. Install the female to male cable (P/N 23242476) to the module (2).
  - 4.3. Connect the UHF adaptor (1) and the female to male (2) connector to the vehicle cables.

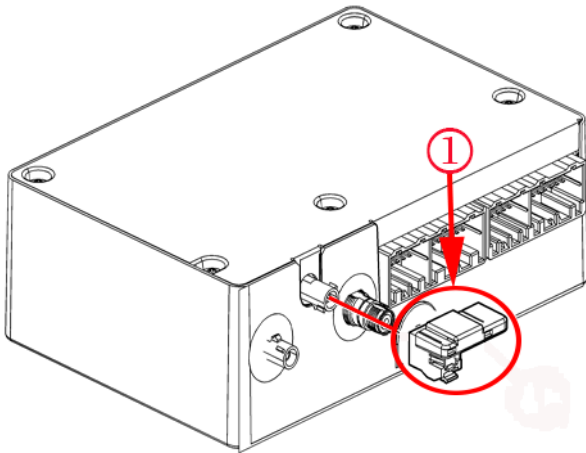
- During the installation of the OnStar® 3G/4G LTE module there may be interference with the module to the bracket not allowing the module to fully seat into place. If this occurs please refer to the “OnStar® Module Bracket Modification” section at the end of this bulletin.
  - Some modules are not as thick as the original modules and require installation of foam to the mounting bracket to prevent movement of the module. Refer to the “OnStar® Bracket Modification” section at the end of this bulletin.
  - For labor time adjustment for the modification, please refer to the “OnStar® Bracket Modification” section at the end of this bulletin for information.
2. If installing the modules P/N 23230482, 23230536, 23230537, 23235220, 23235227, 23235234 and 23383877, transfer the Bluetooth Antenna(1), if equipped, to the new module.

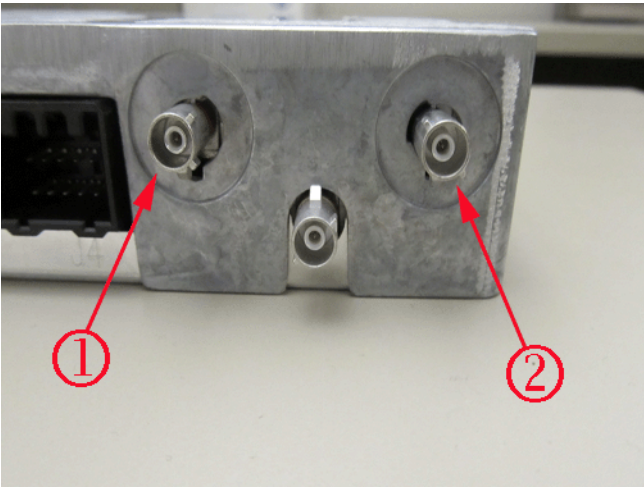
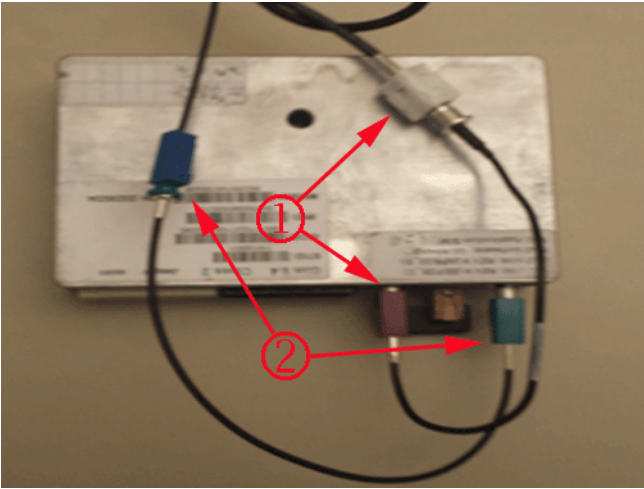
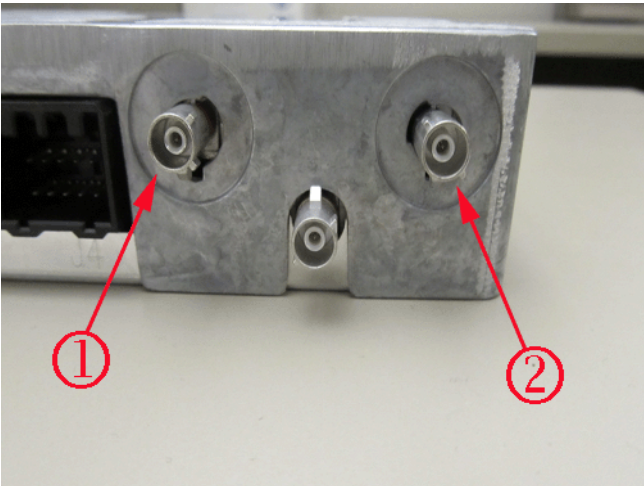
**Note:** The vehicle may have two different configurations, with or without UHF cable. Use the appropriate procedure below:

5. If the vehicle requires a UHF adaptor cable (P/N 23242478) proceed with this step:
- 5.1. Install the UHF adaptor cable (P/N 23242478) to the antenna connector (1) of the module.
  - 5.2. Install the female to male cable (P/N 23242476) to the module (2).
  - 5.3. Connect the UHF adaptor (1) and the female to male (2) connector to the vehicle cables.

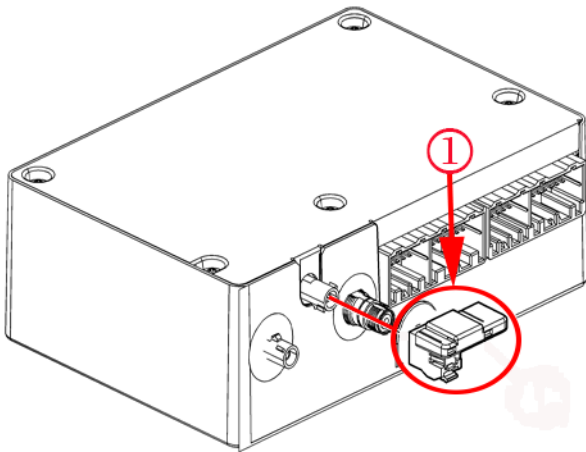
- During the installation of the OnStar® 3G/4G LTE module there may be interference with the module to the bracket not allowing the module to fully seat into place. If this occurs please refer to the “OnStar® Module Bracket Modification” section at the end of this bulletin.

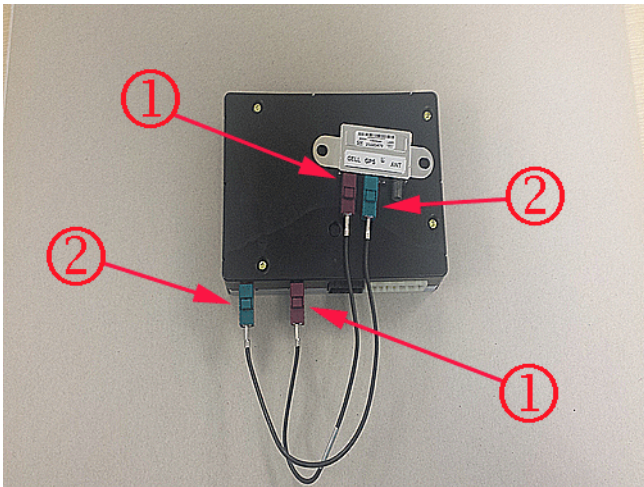
**Note:** During installation of the antenna cable and the cellular cable to the splitter, if the cables inadvertently become incorrectly installed, the technician may notice a red LED with DTCs B101D-3C and B101D-F0 set as current in the OnStar VCIM.

**Note:** The “upgrade” splitter is an additional piece of hardware and must be installed at the VCIM. If present, DO NOT remove any existing splitters during installation.

4. Connect the male to male cable (P/N 23310710 ) to the cellular connector (1) to the splitter as shown above.
5. Connect the male to male cable (P/N 23242477) to the GPS connector (2) to the splitter as shown above.

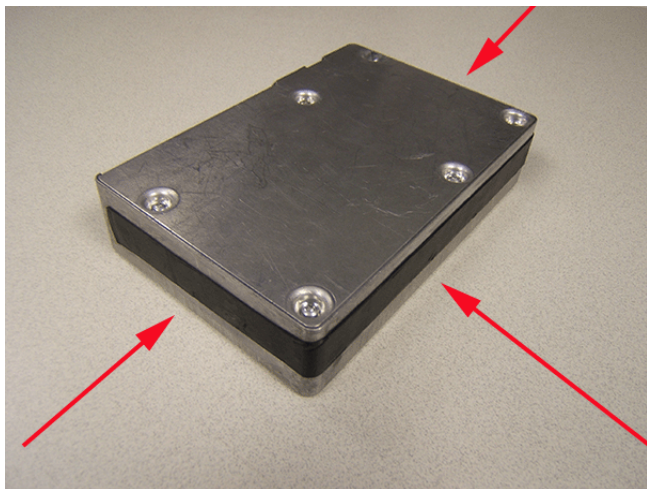
**Note:** Wrapping the module with rubber tape will help prevent movement in the bracket after installed.

Wrap the new module with Scotch™ Linerless Rubber Splicing Tape 130C, 19 mm (3/4 in) wide, (rubber tape) or equivalent from left to right, covering the back side of the module as illustrated.
