# Service Bulletin

**Subject:** Information on Vibration Analysis and Diagnostic

**Models:** 2014 Chevrolet Silverado 1500  
 2015-2018 Chevrolet Silverado 1500  
 2014 GMC Sierra 1500  
 2015-2018 GMC Sierra 1500  
 EXCLUDES HD Trucks

*This PI has been revised to add 2018 Model Year. Please discard PI1354F.*

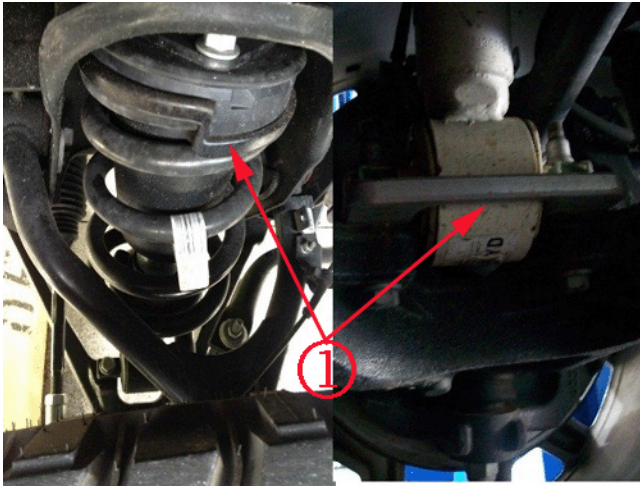
1. Inspect the truck for any aftermarket equipment installations. For example: non factory tires, wheels and/or lift kits or leveling kits – shims installed as shown above. Aftermarket equipment does include running boards, bug deflectors, and window shades, etc. Remove any aftermarket that might cause vibration transmission paths.
2. Mark each tire valve stems location on the tire. This will be utilized to check for tire slippage on the rim.

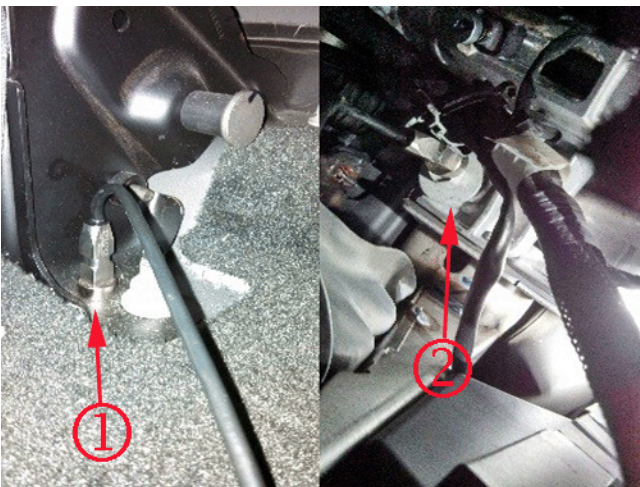
3. Using a Pico Oscilloscope Diagnostic Kit, mount the PicoScope vibration sensor on one of the two locations shown above.

- Seat Vibration – mount the sensor to the front right corner of the driver's seat bracket (1).

- Steering Wheel Vibration – mount the sensor to the steering wheel bracket (2) under dash.

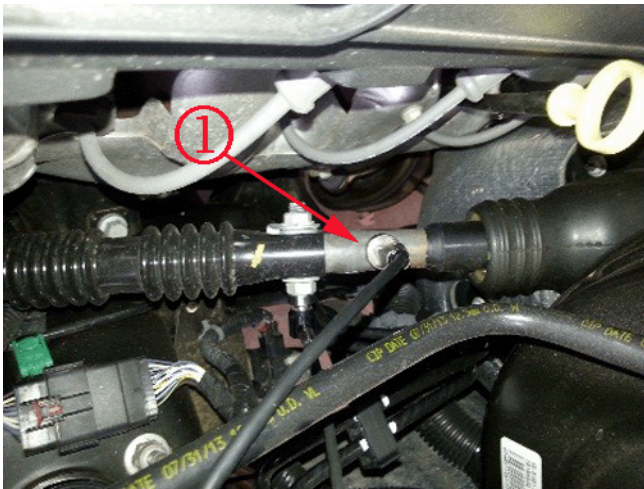
4. This step should be only be used if the vibration can be felt while running the vehicle on the rack. Mount the sensor on the steering shaft ( under the hood as illustrated above.

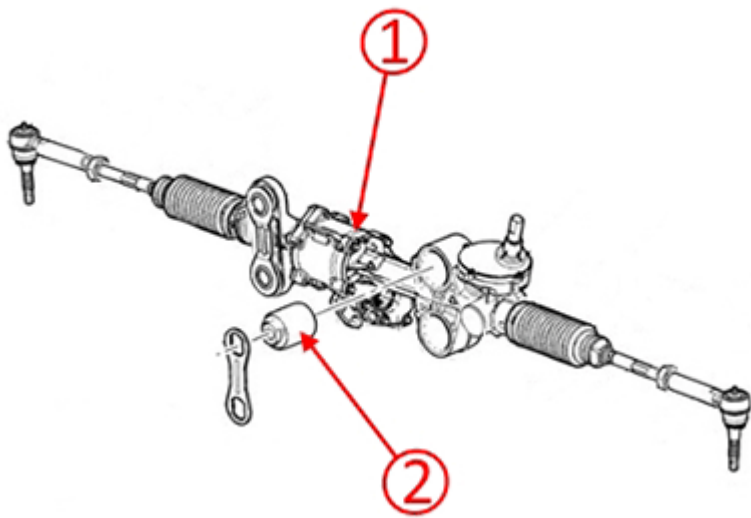
*A revised steering bushing (2) has been released to address customer vibration concerns. After various testing and measurement of the T1 vibration, a vibration path from the tie rods =>steering rack=>steering bushings=>frame=>Body Mount=>Cabin Floor=>Seat has been identified. To help isolate the steering rack (1), a revised hydraulic bushing has been released and tuned to the T1 frequency. The new steering bushing dampens minor T1 vibrations. This is the reason that the causal part (normally the Tire/Wheel Assembly) must be corrected first. If the T1 vibration is over 20-25m/g's, the bushings will have little to no effect.*

For vehicles with T1 vibrations under 20-25m/g's, replace steering bushing per parts catalogue. Utilize SI procedure "Steering Gear Mount Bushing Replacement" for replacement of the steering bushings.

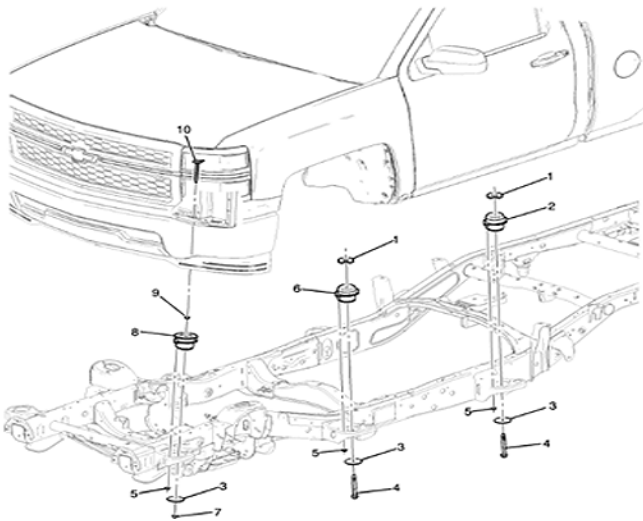
**Replace Rear Cab Mounts - Regular Cab Models Built Prior To November 28, 2017**

A revised Rear Cab Mount has been released to address customer vibration concerns. After various testing and measurement of the T1 vibration, vibration path from the tie rods =>steering rack=>steering bushings=>frame=>Body Mount=>Cabin Floor=>Seat has been identified. To help isolate the cab, a revised Cab Mount has been released and tuned to the T1 frequency. The new cab mount dampens minor T1 vibrations. This is the reason that the causal part (normally the Tire/Wheel Assembly) must be corrected first. If the T1 vibration is over 20-25m/g's, the cab mount will have little to no effect.

Correction: Replace Rear Cab Mount with Revised part number.

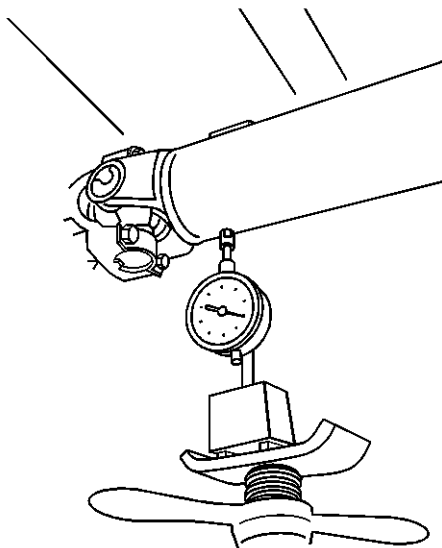
5. Mount the GE-7872 Magnetic Base Dial Indicator Set, or equivalent, or the GE-8001 Dial Indicator Set, or equivalent, to the vehicle underbody or to a service stand positioned just clear of the U-joint yoke weld on the prop shaft.
6. Rotate the drive pinion axle flange, torque tube input flange, transmission output, or transfer case output flange by hand while take runout measurements of the prop shaft. The prop shaft will rotate more easily in one direction than in the other. If necessary, the tire and wheel assemblies and even the brake caliper assemblies can be positioned and supported aside, or the brake drums can be removed from the drive axle to provide easier rotation of the prop shaft.

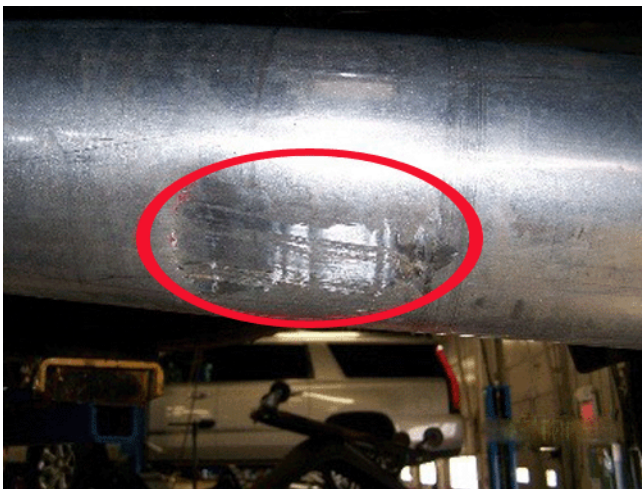
- Inspect the propeller shaft for dents or damage. There have been many cases of dented propeller shafts.
- For 4WD Trucks, remove the rear propeller shaft, seal output shaft and drive the vehicle in 4WD. If the vibration is gone, the rear prop shaft could be the problem.
- For vehicles with a 3:08 with a one-piece steel shaft, this can be replaced with a one-piece aluminum one that is utilized on all 3:42 and 3:73 ratios (K15543 and K15753 Models only).

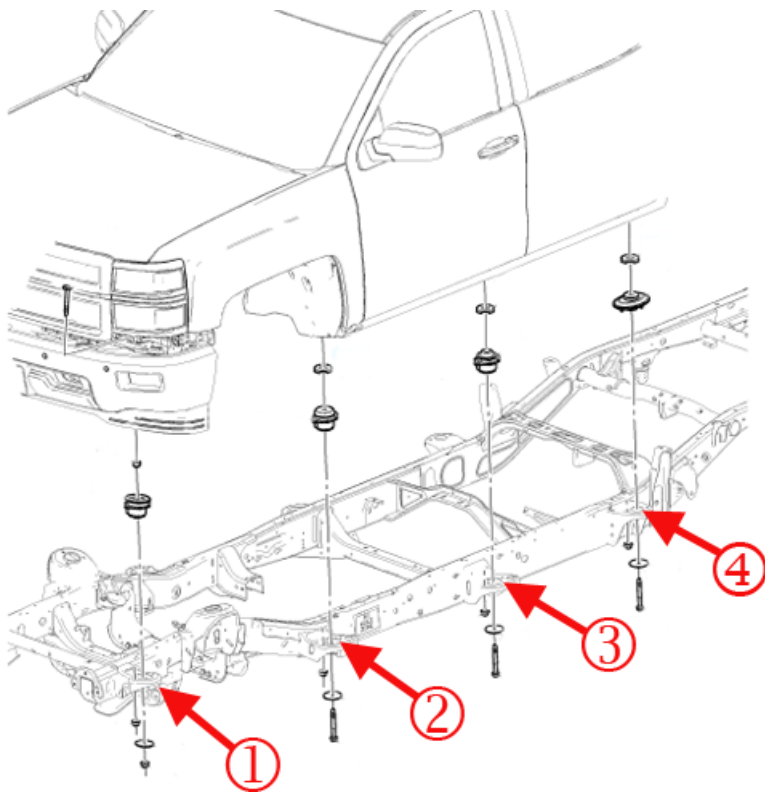
The numbers in the picture below indicate the specific mount position. The mounts on the passenger side of the vehicle are identified the same way. This will assist the technician to identify the correct location of each mount so they can be torque to the proper specification.

- 1 = body mount cushion front
- 2 = body mount cushion position number 1
- 3 = body mount cushion position number 2
- 4 = body mount cushion position number 3

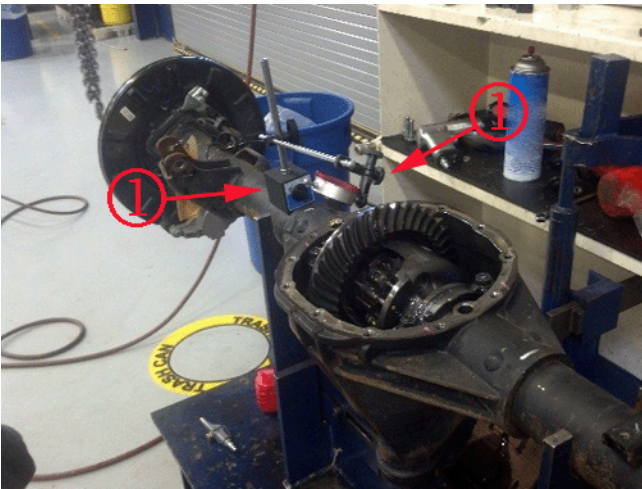
**Note:** The illustration above is for reference only. The differential does NOT need to be removed from the vehicle.

3. Set the J-8001-3 indicator (1) so that the stem is aligned with the gear rotation (1) and square to the tooth angle.
4. Hold the drive pinion stationary and move the ring gear back and forth.
5. Repeat the measuring procedure at **each tooth** around the ring gear.
6. The difference between the backlash at all of the measuring points should not vary by more than 0.05 mm (0.002 in).
7. If the difference between the backlash at all of the measuring points varies by more than 0.05 mm (0.002 in), inspect for burrs, a distorted case flange or uneven bolting.
8. If the difference between all the measuring points is within specifications, the backlash at the minimum lash point measured should be 0.08-0.25 mm (0.003-0.010 in) with a preferred backlash of 0.13-0.18 mm (0.005-0.007 in).
