Service Bulletin

Subject: Information on Vibration Analysis and Diagnostic

Models: 2014 Chevrolet Silverado 1500
 2015-2018 Chevrolet Silverado 1500
 2014 GMC Sierra 1500
 2015-2018 GMC Sierra 1500
 EXCLUDES HD Trucks

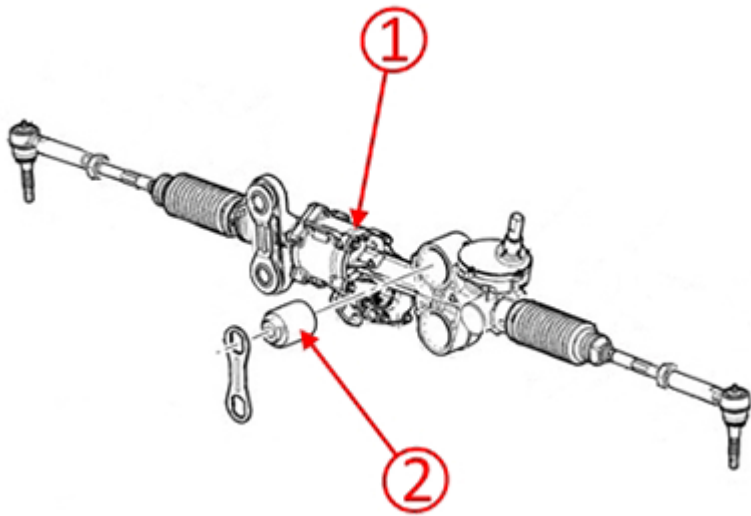
A revised steering bushing (2) has been released to address customer vibration concerns. After various testing and measurement of the T1 vibration, a vibration path from the tie rods =>steering rack=>steering bushings=>frame=>Body Mount=>Cabin Floor=>Seat has been identified. To help isolate the steering rack (1), a revised hydraulic bushing has been released and tuned to the T1 frequency. The new steering bushing dampens minor T1 vibrations. This is the reason that the causal part (normally the Tire/Wheel Assembly) must be corrected first. If the T1 vibration is over 20-25m/g's, the bushings will have little to no effect.

For vehicles with T1 vibrations under 20-25m/g's, replace steering bushing per parts catalogue. Utilize SI procedure "Steering Gear Mount Bushing Replacement" for replacement of the steering bushings.

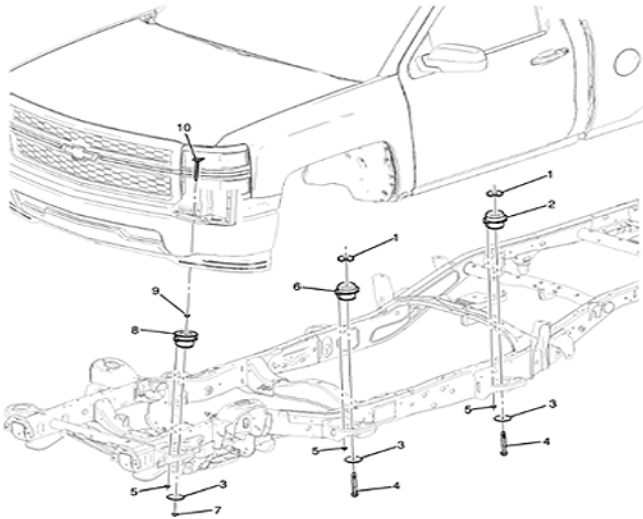
A revised Rear Cab Mount has been released to address customer vibration concerns. After various testing and measurement of the T1 vibration, vibration path from the tie rods =>steering rack=>steering bushings=>frame=>Body Mount=>Cabin Floor=>Seat has been identified. To help isolate the cab, a revised Cab Mount has been released and tuned to the T1 frequency. The new cab mount dampens minor T1 vibrations. This is the reason that the causal part (normally the Tire/Wheel Assembly) must be corrected first. If the T1 vibration is over 20-25m/g's, the cab mount will have little to no effect.

Correction: Replace Rear Cab Mount with Revised part number.
