Service Bulletin

Bulletin No.: 17-NA-221

Subject: Poor Engine Performance in Extremely Cold Weather Conditions for LE2 Engines, Charge Air Cooler (CAC) Icing - Malfunction Indicator Lamp (MIL) Illuminated, DTC P0299, P0236, P2227, P00C7 Set

Brand:	Model:	Model Year:		VIN:		Engine:	Transmission:
		from	to	from	to		
Buick	Encore	2016	2018	SOP	Sept. 18, 2017	LE2

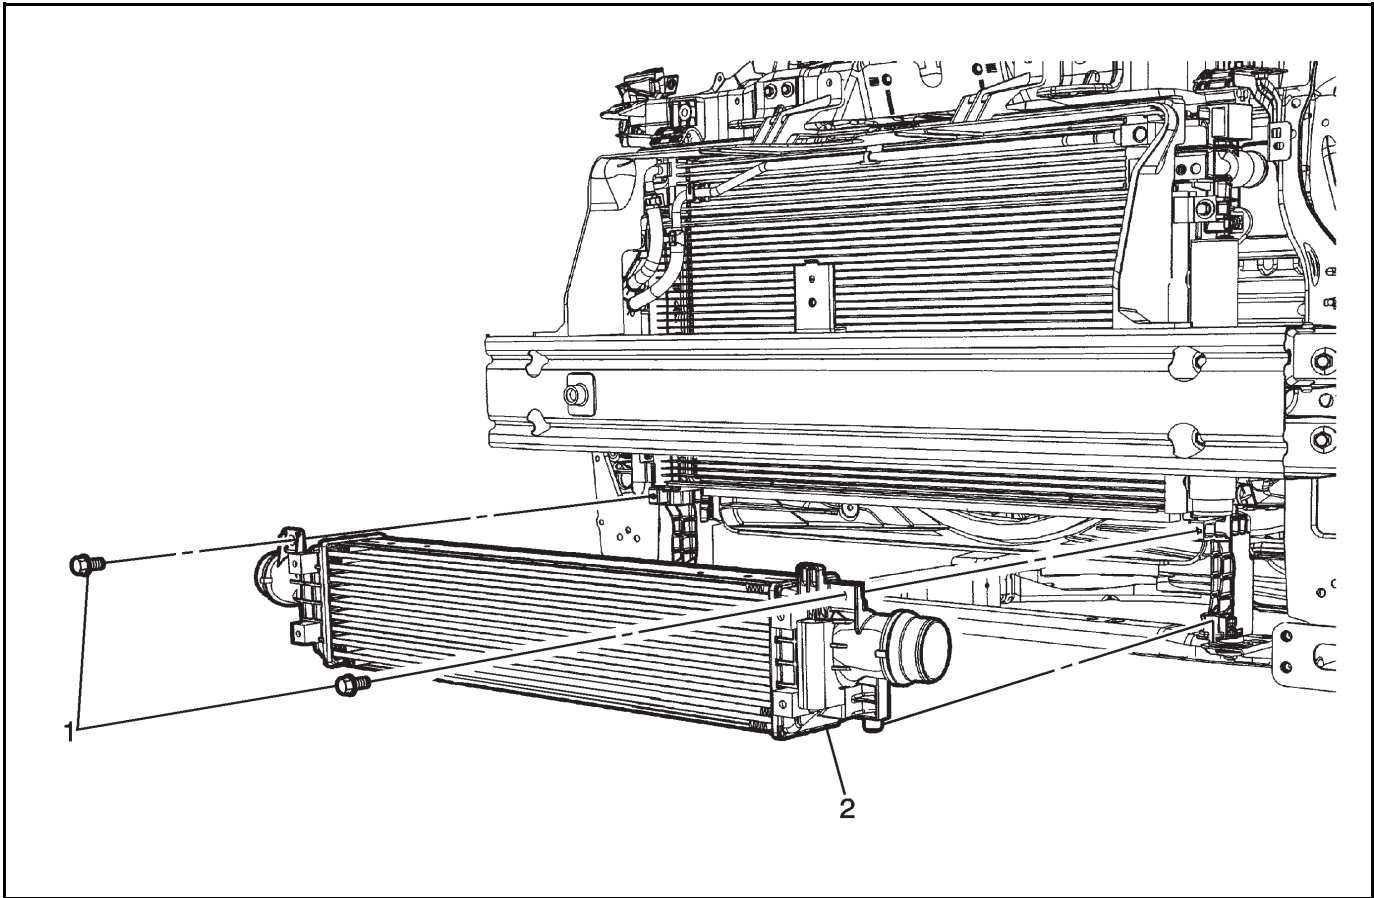
2851444

Cause	This condition may be caused by ice accumulation in the charge air cooler, restricting air flow to the throttle body.
Correction	<p>If any of the above conditions are present, allow time for possible ice build up in the CAC to melt by allowing the vehicle to thaw in a warm climate.</p> <p>If any of the following conditions are validated to be caused by freezing/icing, replace the CAC.</p> <p>If not previously performed, an oil change may be necessary to remove any moisture from the engine. Prior to the oil change, run the engine at idle for an extended period of time to melt any ice in the engine.</p>

1. Install CAC (2). Refer to *Charge Air Cooler Replacement* in SI.

- If the oil change was recently done and no signs moisture has been confirmed, Do Not proceed with procedure.
 - If the oil change was not previously done or moisture has been found in the oil, proceed with procedure.
2. If required, perform an oil change. Refer to *Engine Oil and Oil Filter Replacement* in SI.
