Service Bulletin

Subject: Information on Rough Idle, Crank No Start, Extended Crank or Misfire Due to Excessive Carbon on Top of the Valves or Sticking Valves, Malfunction Indicator Light (MIL) Illuminated - DTC P0300, P0301, P0302, P0303, P0304, P0305, P0306, P0307, P0308 Set

This Bulletin replaces PIP5029H. Please discard PIP5029H.

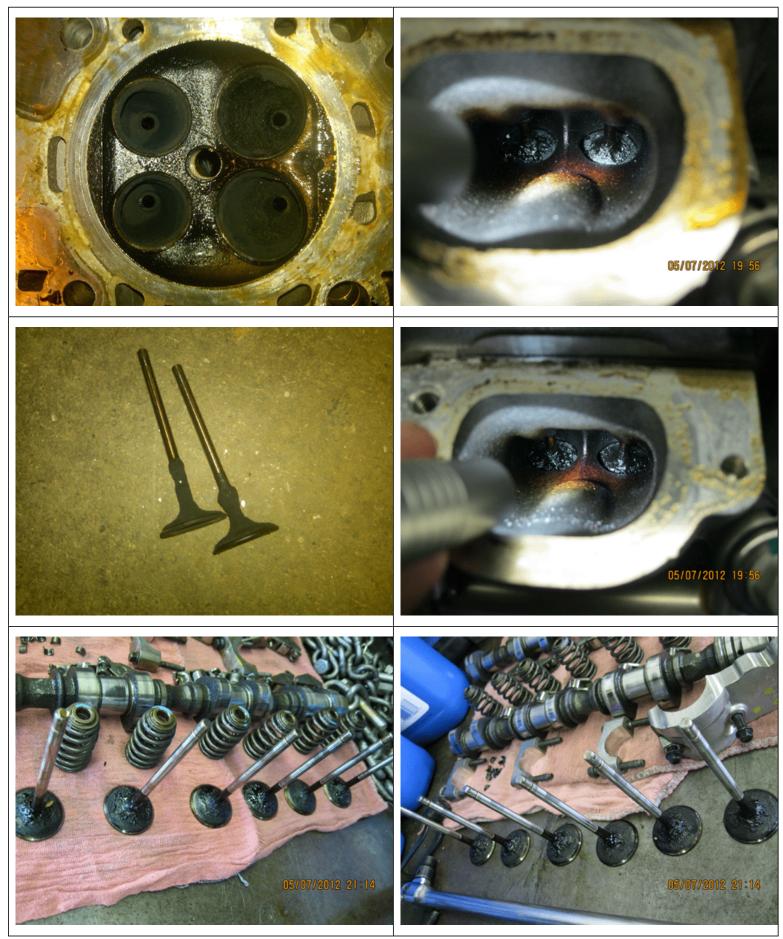
The graphics below may show typical carbon build-up during engine dissemble and inspection of the cylinder heads:

When the engine is cold, the compression on multiple cylinders may be at 0 PSI (0 kpa). The engine also may pop through the intake or exhaust while cranking and the spark plugs may be fuel fouled when inspected. Some engines may also experience valve damage or cam followers that are out of position as a result of this.

- If there is no sign of valve damage or cam followers that are out of place, perform the following procedure to free up sticking valves and to remove carbon from the valves and pistons.
- If valve damage is present or if there are cam followers that are out of place, perform engine mechanical repairs as necessary to correct the concern and then perform the procedure below to prevent the concern from returning.
- · Perform an upper engine and valve cleaning procedure.
- Below are examples of valves that have gone through a top engine cleaning procedure.
