# Preliminary Information

PIP5498B SES Lamp P050D P0300 Setting On A Cold Start And/Or a Run Rough Warm with No codes

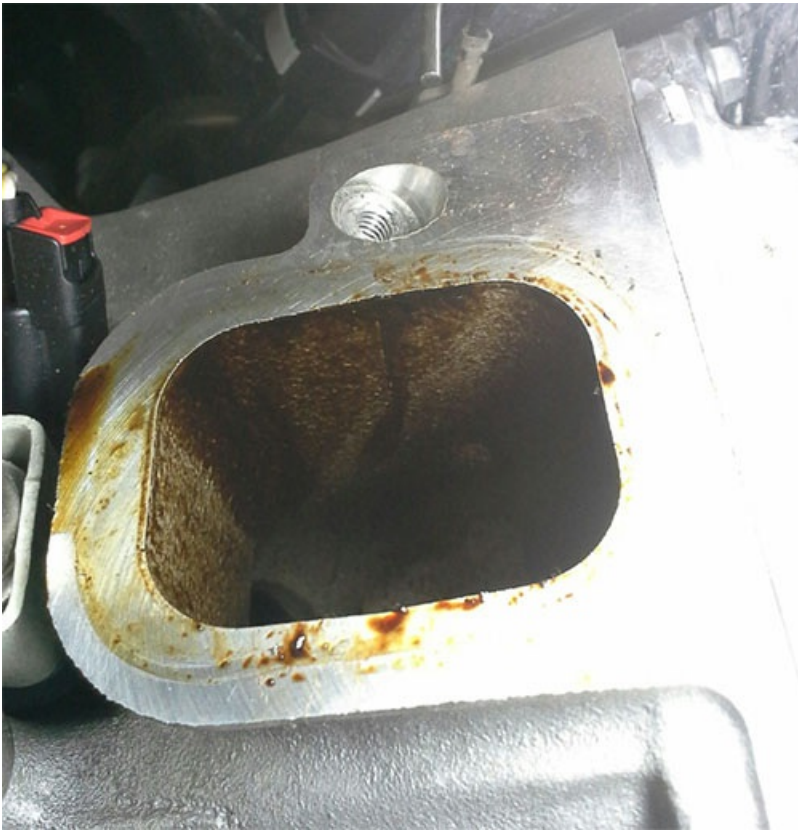
If the head casting line is the concern the intake port will be wet with a coolant oil mix.

This could be the cause of a running rough warm concern with or without codes.

The location of where the coolant is running down in the port will also look washed down.

If this is found the cylinder head will need to be replaced.

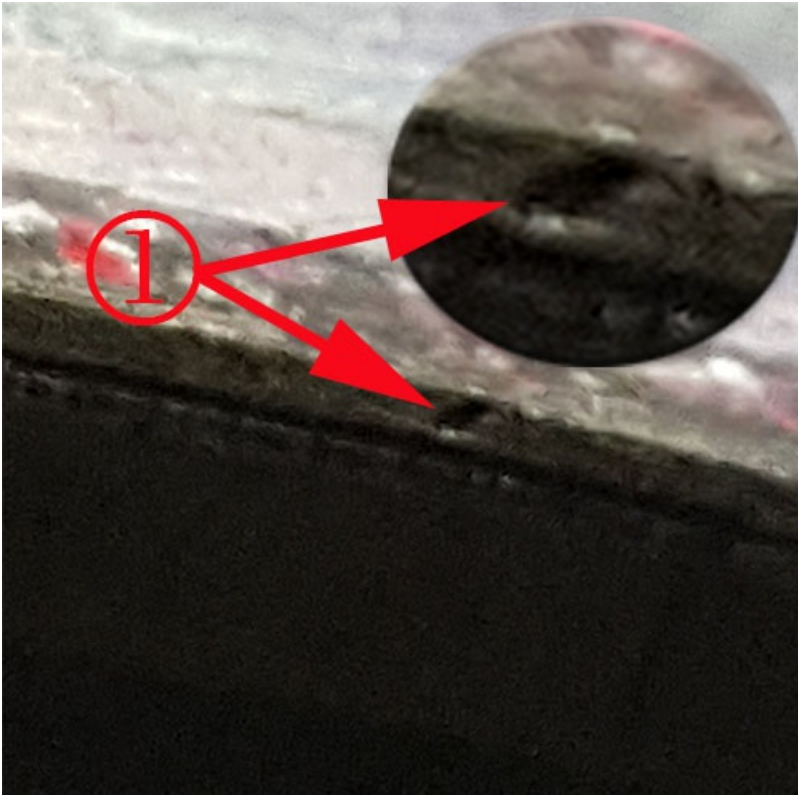
For coolant entry at the liner to deck face casting of the cylinder bore.

It is hard to see the actual source (pin hole) but it usually streams down the liner so that you can see it with a borescope.(Sometimes) The top of the piston will be steam cleaned.

Do not confuse residual fuel on the piston crown / surface as coolant. Some fuel residue may be present and can be mistaken as coolant (reason for the cooling system Dye to be added). Use black light to confirm the liquid is coolant. If this concern is present, do not replace the cylinder head because that will not repair this concern. Call PQC per the latest version of [16-NA-338](#), if required, reference this PI and replace the engine.
