Preliminary Information

PIT5452B Upper Steering Column Or Steering Wheel Pop Click Tick Snap Itch Noise While Turning The Steering Wheel

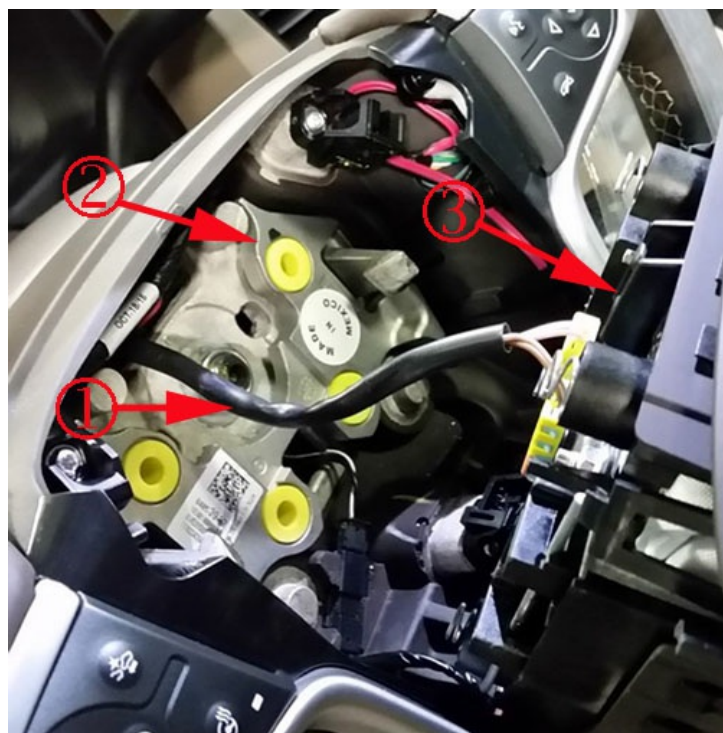
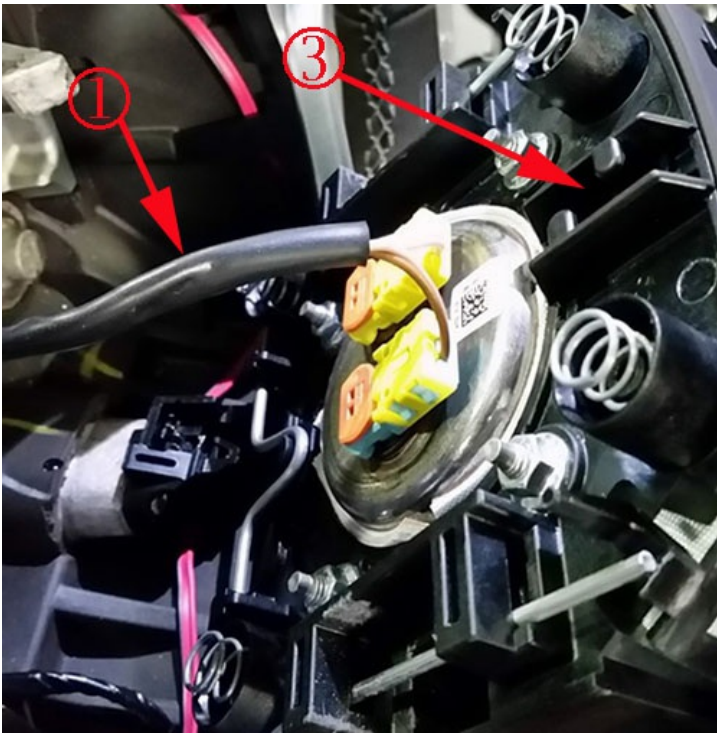
(Chevrolet / GMC design shown, Cadillac similar)

Cause-1: This noise may be caused by mis-routed airbag module wiring coming in contact with the vibration damper plate in the steering wheel, causing the plate to contact the side of the steering wheel while turning.

It has been found that if the steering wheel to airbag wiring harness (1) is Not routed within the wiring channel (3) molded into the back of the airbag module, the harness could contact the damper plate (2) within the steering wheel, and cause the damper plate to contact the side of the steering wheel during turns.

1. Release the steering wheel airbag retainers from the steering wheel. Refer to Steering Wheel Airbag Replacement.
2. Tilt the steering wheel airbag upward; do Not disconnect the electrical connectors from the airbag.
3. Inspect whether the airbag wiring (1) is routed in the channel (3) molded into the back of the airbag.
4. Seat the wiring harness (1) into the wiring channel (3) molded into the back of the airbag module. This will keep the harness from contacting the damper plate (2).

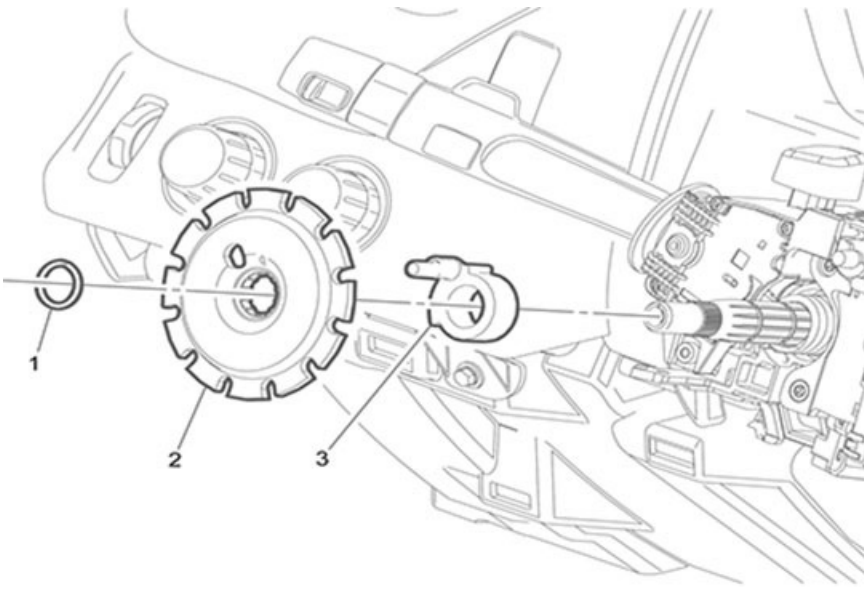
Cause-2 (RPO N38 Only): This noise could be caused by the upper column bearing race being slightly out of alignment.

1.2 Remove the steering column lock plate ring (1), lock plate (2) and cancel cam (3) from the column.
