Service Bulletin

Subject: GM of Canada OnStar® Cellular Communication Upgrade

Models: 2000-2014 GM Passenger Cars and Light Duty Trucks
2015 Buick Enclave
2015 Cadillac Escalade Models (Built W/O VV4)
2015 Chevrolet Camaro, Express, Traverse
2015 Chevrolet Silverado 2500/3500, Suburban, Tahoe (Built W/O VV4)
2012 Chevrolet Colorado
2015 GMC Acadia, Savana
2015 GMC Sierra 2500/3500, Yukon Models (Built W/O VV4)
2012 GMC Canyon
2005-2010 Pontiac Vibe
Equipped with OnStar® (RPO UE1)

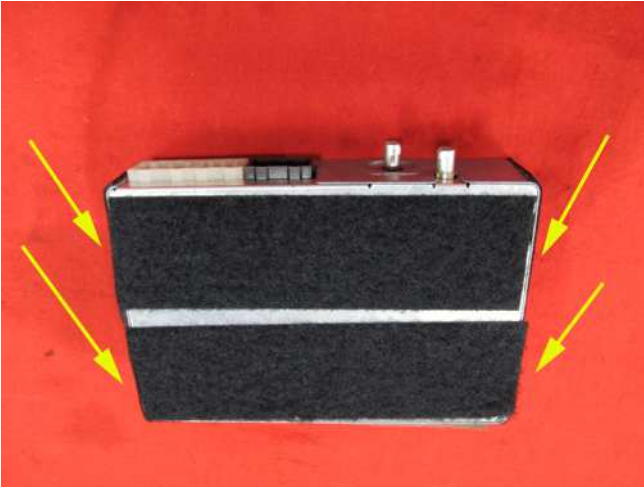
Note: After the removal of the original OnStar® module, modification of the new module is required to secure the module into place.

2. Obtain two strips, approximately 177 mm (7 inches) in length, of 2" Velcro® 191195 Reclosable Loop Fastener Tape (hook and loop) or equivalent and apply one side of the tape to the bottom of the module as shown above.
