Service Bulletin

File in Section: 06 - Engine
Bulletin No.: 14-06-01-002
Date: August, 2014

Subject: Crankshaft Rear Oil Seal — Oil Leak

Models: 2013 Buick Enclave, LaCrosse
2013 Cadillac ATS, CTS, SRX, XTS
2013 Chevrolet Camaro, Captiva, Equinox, Impala, Traverse
2013 GMC Acadia, Terrain
Equipped with 6 CYL, 3.0L — RPO LFW
Equipped with 6 CYL, 3.6L — RPO LFX or LLT
Vehicles Built Between September 1, 2012 and March 13, 2013

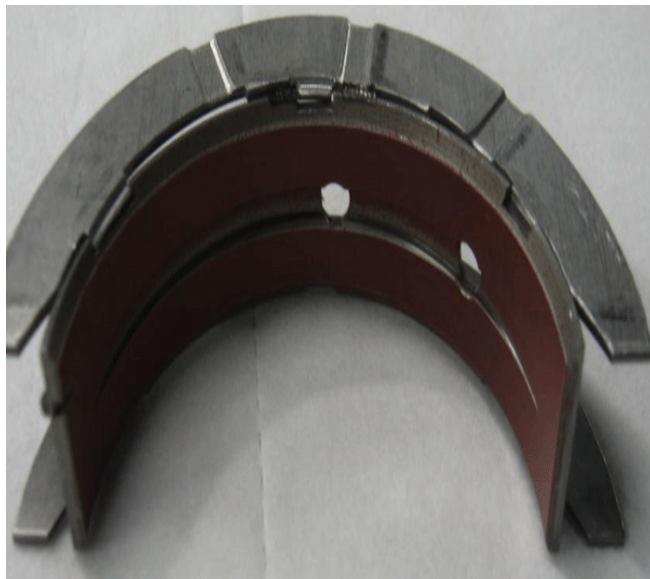
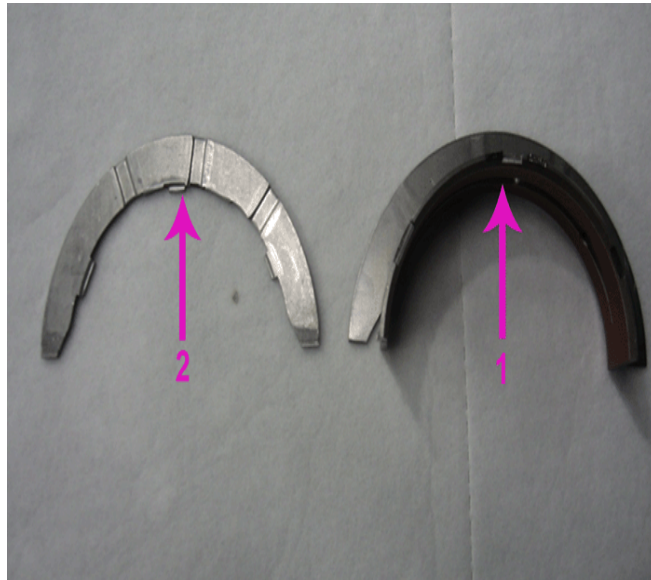
3959063

5. Typical view of a good crankshaft #3 thrust bearing with both thrust wings in place and a view of the crankshaft #3 thrust bearing (1) with one wing (2) broken off. The thrust bearing wing (2) is usually found in the engine oil pan, sometimes under the oil pan scraper. Ensure the failed thrust bearing wing is removed from the engine oil pan.
