Service Bulletin

Bulletin No.: 17-NA-384

Subject: Squeak, Rattle or Creak Coming from Second Row/Rear Seat Area

Brand:	Model:	Model Year:		VIN:		Engine:	Transmission:
		from	to	from	to		
Cadillac	XT5	2017	2018	SOP 2017	July 17, 2017	All	All
GMC	Acadia (VIN N)

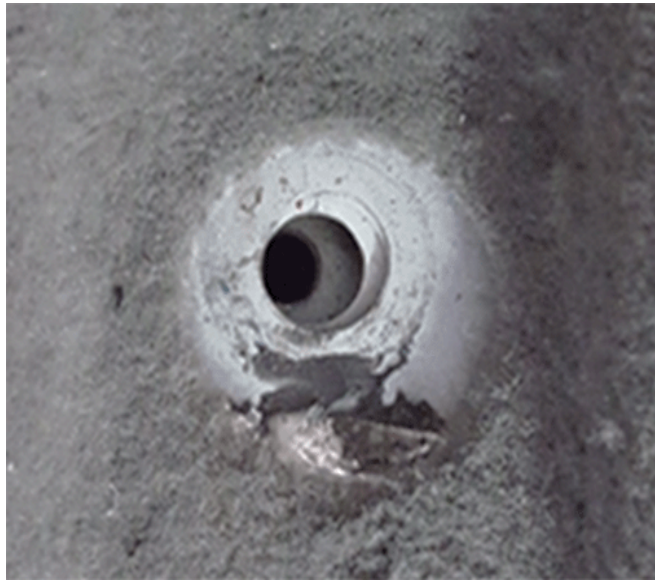
<p style="text-align: right;">4911773</p> <ul style="list-style-type: none"> • Possible "winking" condition of floor pans right rear seat outboard track rear bolt hole on units built prior to May 15, 2017. <p>Note: The "winking" is caused by excessive overlap of body panels and, as shown in the graphic above, the sheet metal holes are offset. This is most commonly found at the right rear fastener location of the right rear seat.</p> <ul style="list-style-type: none"> • A seat track synchronization/torque condition may require a torque sequencing of the seat attachment bolts for vehicles built up to July 17, 2017.

Correction	<p>Note: Perform the "winking" inspection, and repair procedure as necessary first, prior to performing the torque procedure.</p> <p>For vehicles exhibiting the condition, follow the Service Procedure below to inspect for and correct the winking condition, and also complete the torque sequencing procedure.</p>

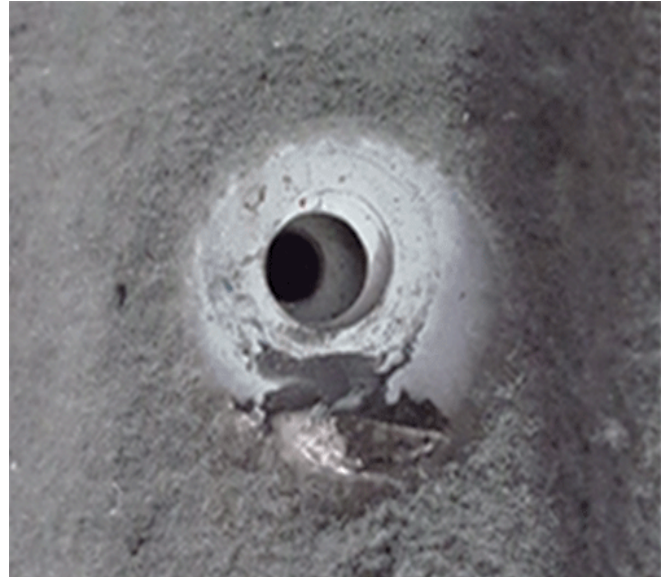
4911773

the right rear seat fastener location for possible “winking” condition:

- If “winking” condition DOES exist, continue ahead to step #3 and remove sheet metal material.

3. Using a dremel, or suitable tool, grind a small amount of material from the floor sheet metal opening. Grind only enough of the overlapping metal to allow clearance for the seat bolt.
4. Use an air gun to blow out any metal debris in the nut and hole area.

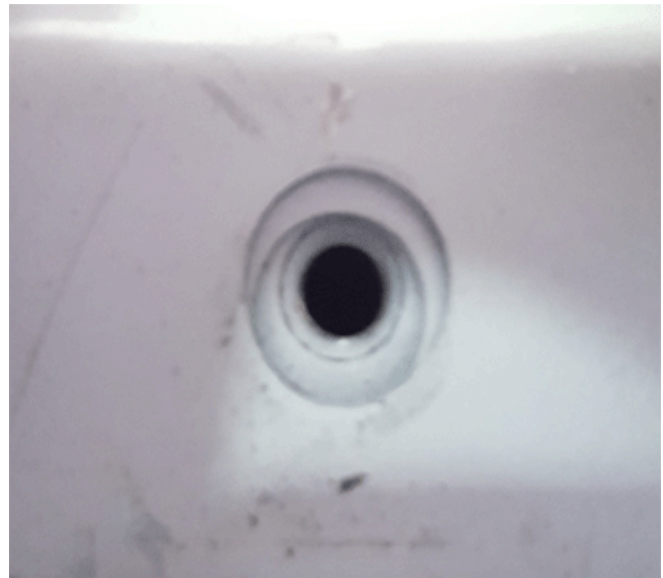
4911781

Note: In the graphic example above, the sheet metal is still offset, but the nut is centered enough to avoid contact of the seat bolt to the sheet metal.

- If “winking” condition DOES NOT exist, jump ahead to step #5 and follow the torque sequence procedure.
