# **Service Bulletin**

Bulletin No.: 15-06-01-002F

Subject: Engine Misfire/Tick Noise, Malfunction Indicator Lamp (MIL) Illuminated, DTC

Models: 2015-2018 Cadillac Escalade

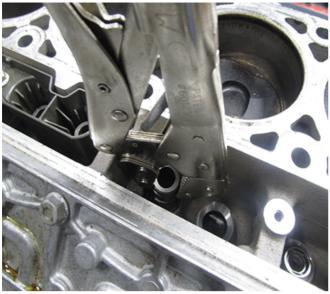
4250109

There are two approved processes for removing the lifter when stuck in the bore.

## 1. Use vice grips with a slide hammer.

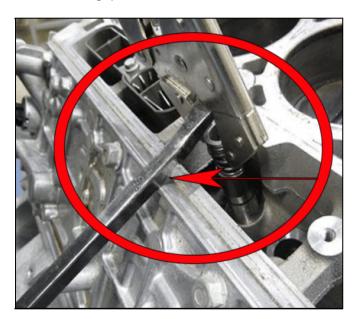
4921302

**Note:** Be sure **NOT** to pry on the sealing surface of the block, as shown in the illustration above.

## 2. Use vice grips with a small pry bar.
