# Service Bulletin

Bulletin No.: 16-NA-051

**Subject:** Active Shutters Inoperative, Malfunction Indicator Lamp (MIL) Illuminated - DTCs P059F, P0071, P0072, P0073, P0074, P3056, U1345, U1501, U1510, U1511 Set

Brand:	Model:	Model Year:		VIN:		Engine:	Transmission:
				from	to		
Buick	LaCrosse	2017	2018				
Chevrolet	Malibu (VIN Z)	2016	2018

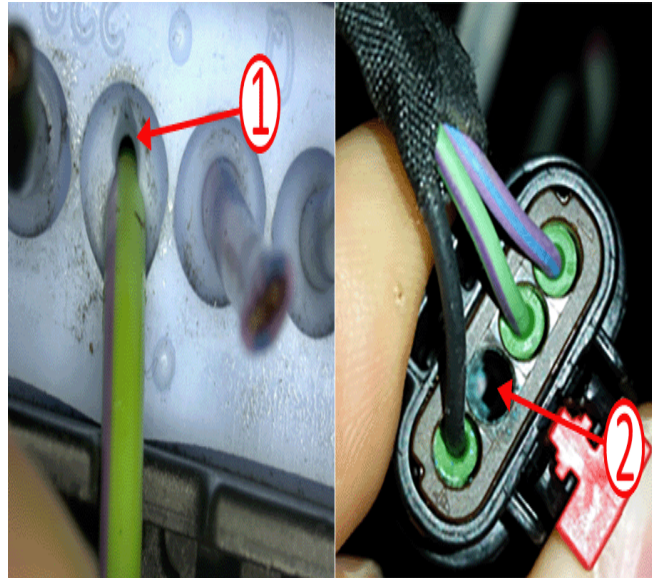
4787001

- Moisture intrusion past damaged (1) and/or missing (2) seals located in the B9, M60B and/or X119 connectors for the ambient air temperature sensor wiring harness.
- Snow and/or ice buildup in the front lower grille area of the vehicle, which could prevent the active aero shutters from opening or closing.

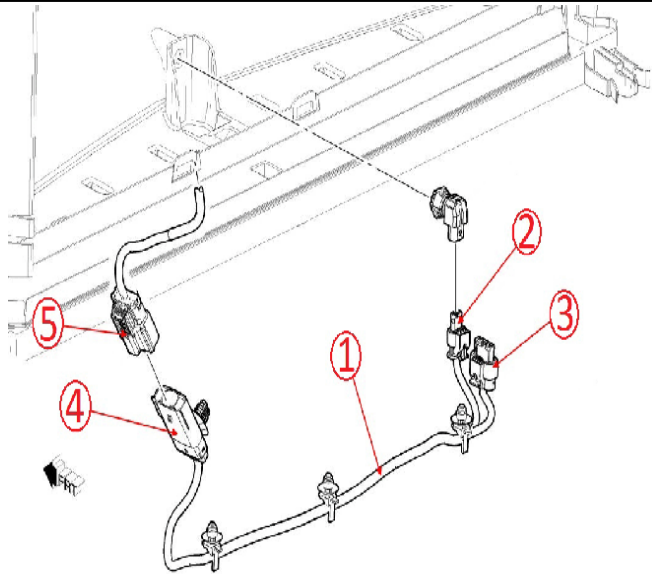
4527562

Inspect the ambient air temperature sensor wiring harness connectors B9 (2), M60B (3) and the X119 (4, 5) for any signs of corrosion.

**Notice:** The Ambient Air Temperature Sensor Wiring Harness must be replaced and dielectric grease must be applied to all of the connectors for any of the following repairs.

- If any signs of water and/or corrosion was found on the Ambient Air Temperature Sensor Wiring Harness (1), it must be replaced.
- If water and/or corrosion was found at the X119 connector (5), the main body wiring harness connector must be replaced.
- If water and/or corrosion was found at the B9 connector (2), the ambient air temperature sensor must be replaced.
- If water and/or corrosion was found at the M60B connector (3), the active shutter must be replaced.
