# Service Bulletin

Bulletin No.: 17-NA-010

**Subject: Passenger Seat Airbag Warning Message On - DTC B0074 Set**

Brand:	Model:	Model Year:		VIN:		Engine:	Transmission:
		from	to	from	to		
Chevrolet	Impala (VIN 1)	2014	2016				
	Impala	2017	2018

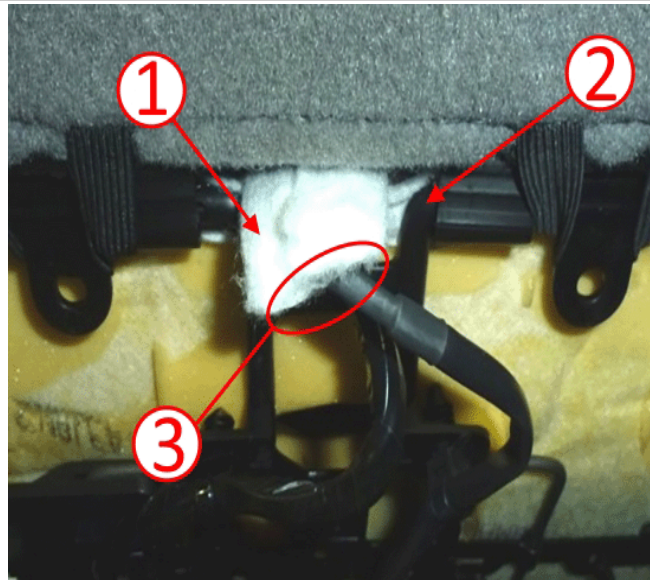
4769349

Inspect the PPS sensor mat pigtail harness routing through the seat suspension and around the frame. The correct routing is shown above.

Inspect the seats wiring harness routing around the seat frame (1):

- Sensor mat harness pigtail (3) may be doubled over and twisted with both the felt patch (1) and harness pigtail trapped between suspension guide and foam (2).
- PPS sensor mat pigtail harness should be routed to allow for minimal stress on the electrical connection system.

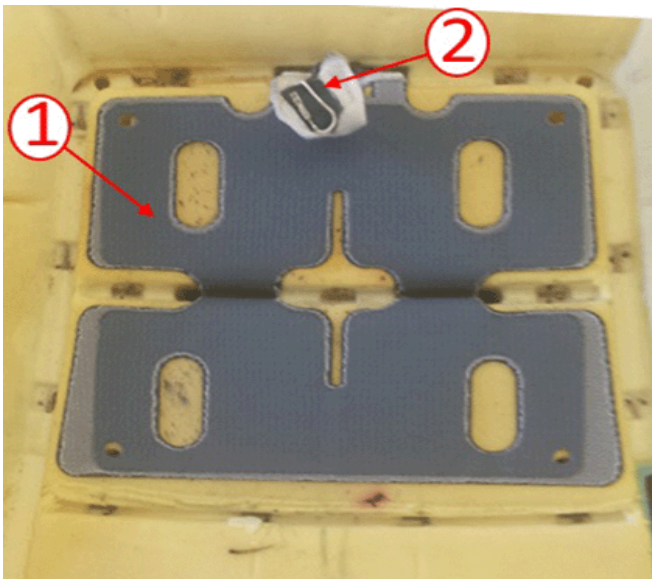
4624719

**Note:** To gain access to the PPS mat (1) and X2 electrical connection at the PPS sensor mat pigtail harness (2), removal of the seat cushion and trim cover from the seat is required.

1. Remove the passenger side seat. Refer to *Driver or Passenger Seat Removal and Installation* in SI.
2. Disconnect the electrical connectors, remove the seat cushion, and de-trim the cushion. Refer to *Front Seat Cushion Cover and Pad Replacement* in SI ([DOC ID 2901727](#)).
3. Using care, pull the PPS sensor mat pigtail harness (2) up through the foam opening.
4. Using care, remove the felt tape from covering the terminals of the X2 electrical connection.

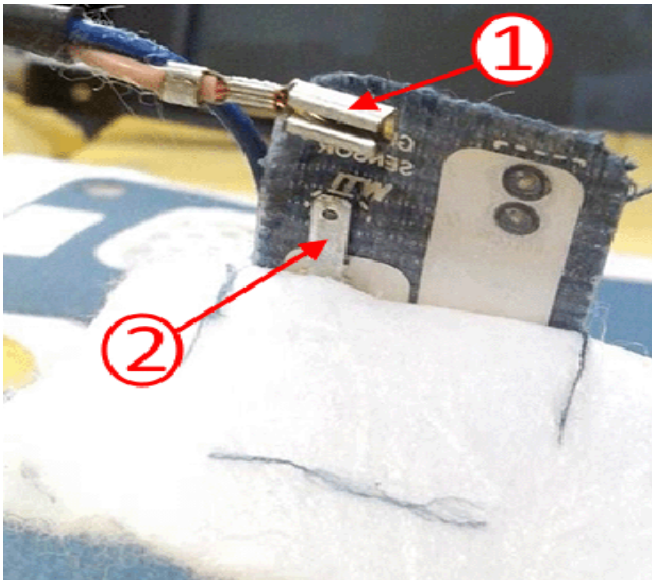
4624711

5. Inspect the PPS sensor mat terminals (1) for loose or unseated connections.
6. If the female terminal is loose, flip the female terminal upside down (180°) from how it was originally inserted before reconnecting to the male blade making sure that it is fully seated.

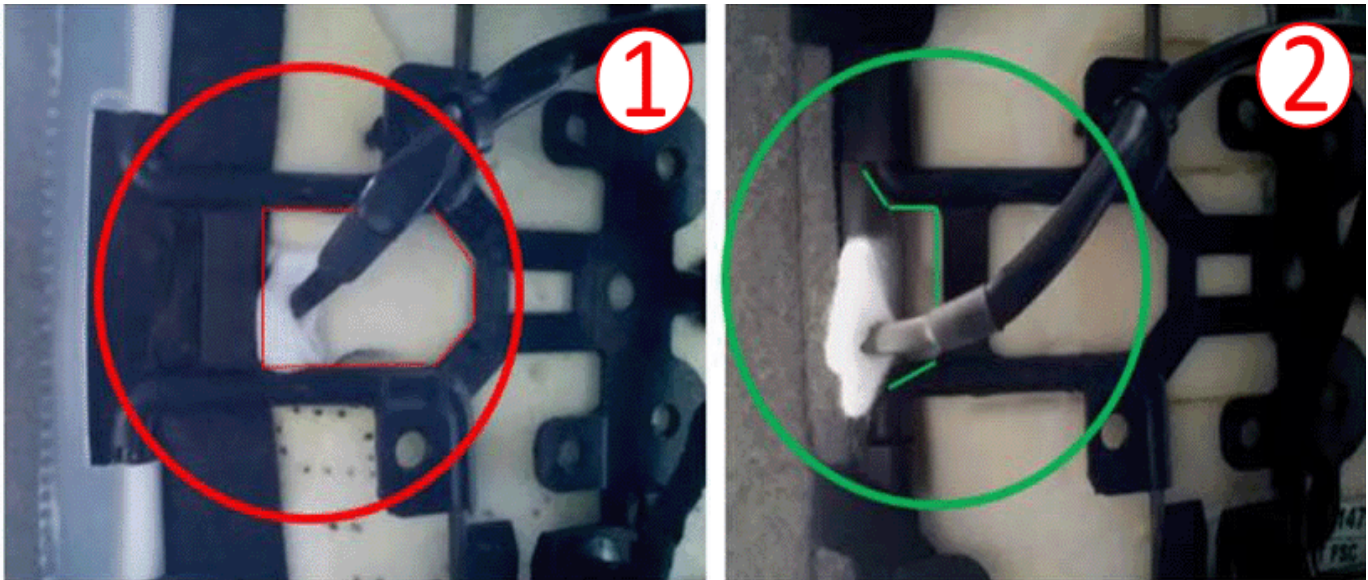
4920551

**Note:** The graphic above depicts the incorrect pigtail harness route (1) and the correct pigtail harness route after repair (2).
