# Service Bulletin

Bulletin No.: 18-NA-007

**Subject:** Malfunction Indicator Lamp (MIL) and/or Service AWD Displayed on Driver Information Center (DIC), Loss of Power Steering Assist, Dead Battery and/or Loss of Communication on HSLAN, DTCs C0800, U0136 Set

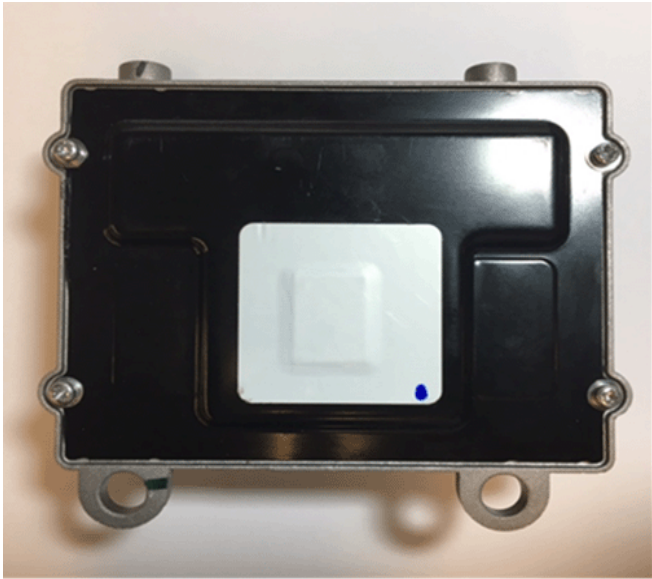
4887542

<p>This condition may be caused by the rear differential clutch module (RDCM) being corroded at the seam between the base plate (black) and the top housing (grey), including the connector and 4 screws.</p>
<p>Correction</p>	<p><b>Note:</b> Only 3% of vehicles have been found to have a corroded RDCM connector. <b>DO NOT</b> replace the RDCM wire harness if there is no evidence of corrosion in the connector.</p>

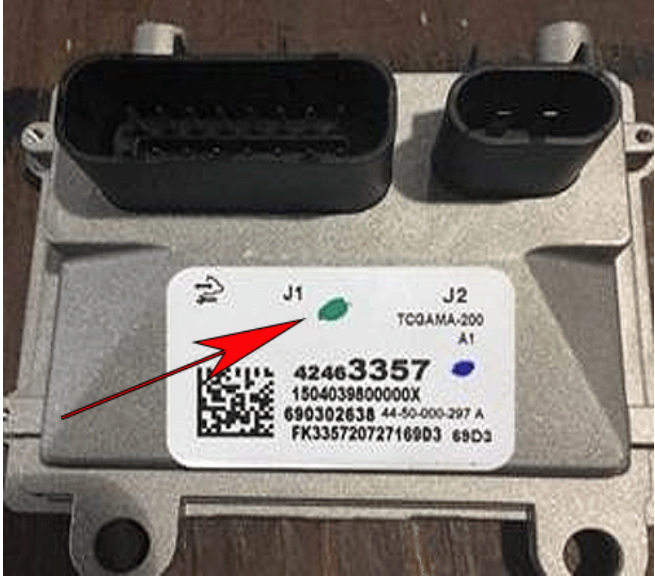
<p style="text-align: right;">4909451</p> <p>Replace the RDCM and inspect associated wiring replacing the connector harness if required.</p> <p>If the replacement RDCM is part number 42463357, inspect the replacement RDCM for the presence of a green dot on the tag, as shown above.</p> <ul style="list-style-type: none"> <li>• If the replacement RDCM has a green dot, install per SI procedures.</li> <li>• If the replacement RDCM <b>DOES NOT</b> have a green dot, order a new RDCM.</li> </ul> <p><b>Important: DO NOT</b> install a new RDCM without a green dot.</p> <ul style="list-style-type: none"> <li>• Future part numbers may not have a green dot. In that case verify that part number 42463357 supersedes to the current part number you have received and use it.</li> </ul>
