Service Bulletin

PRELIMINARY INFORMATION

Subject: Diagnostic Tips: Unwanted Content Theft Alarm Sounds

Models: 2015 Cadillac Escalade
2015 Chevrolet Suburban, Tahoe
2015 GMC Yukon
With Theft Protection Package (RPO UTT)

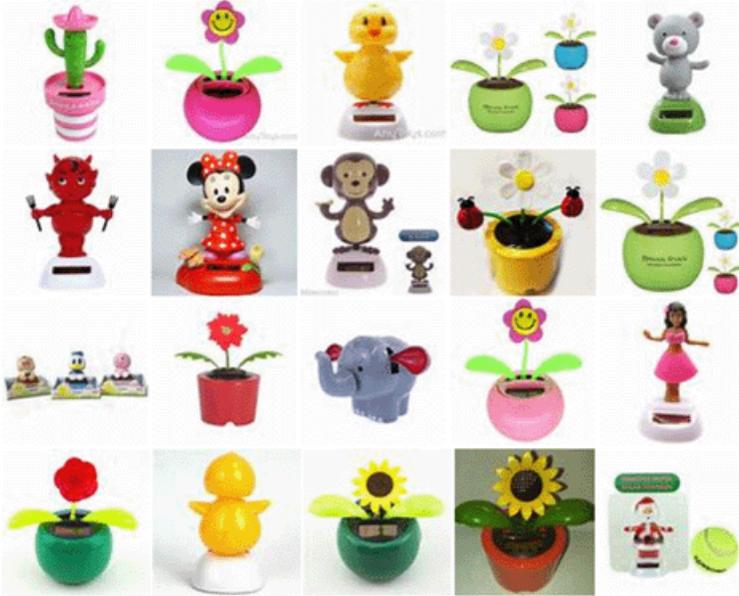
1. Intrusion- Located in the over head console are ultrasonic intrusion sensors. These sensors are used to detect motion inside the vehicle. There have been reports of pets, items hanging from the rear view mirror, solar powered dancing characters (examples below), etc. moving inside the vehicle and triggering the alarm. These items will have to be removed and the system retested before performing any additional diagnostics.
