Service Bulletin

PRELIMINARY INFORMATION

Subject: Headlight Performance (BCM Calibration and Bulbs)

Models: 2015 GMC Sierra
2014 GMC Sierra 1500

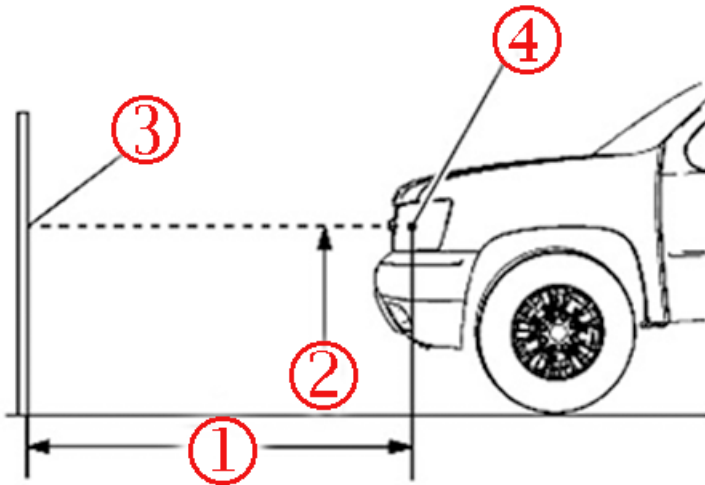
Note: Floor must be level

1. 25 ft (7.62 m)
 2. Height of Horizontal Aiming Line on screen
 3. Aiming Screen or Wall
 4. Reference mark (small circle) on headlamp lens
9. Turn the headlamps ON.
 10. Block the light from projecting onto the screen from the passenger side headlamp. This will allow the cutoff (“top” of the beam pattern) in the beam pattern from the driver’s side to be more pronounced for easier aim verification.
- Important:** DO NOT cover the headlamp, this may cause excessive heat buildup
11. On this vehicle you will be verifying the vertical aim of the cutoff (top of the beam pattern) on the right side of the “step” in the beam pattern.
 12. If the vertical location of the cutoff projected onto the screen or wall differs from the figure below, then an adjustment to the beam pattern location is necessary.

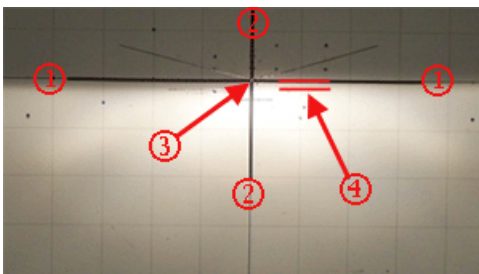
Note: GMC Sierra Low beam pattern (1 Lamp) on wall/aiming screen at 25 ft (7.62 m)

1. Horizontal Aiming Line
2. Reference line only, Not needed for proper aiming
3. Step in beam pattern

4. Top of beam pattern (cutoff line) positioned at the horizontal aiming line +0 / -0.75" (-19mm)
13. Adjust the vertical headlamp aim adjustment screw until the cutoff (top of the beam pattern) on the right side of the beam pattern step is set between the Horizontal Aim Line and 0.75 (19mm)inches below.
14. Repeat the aiming procedure for the passenger's side headlamp while blocking the light from projecting onto the screen from the driver's side headlamp
