# Service Bulletin

**Subject:** Aftermarket ALDL or DLC Interface Devices Causing Multiple Issues

**Models:** 2018 and Prior GM Passenger Cars and Trucks

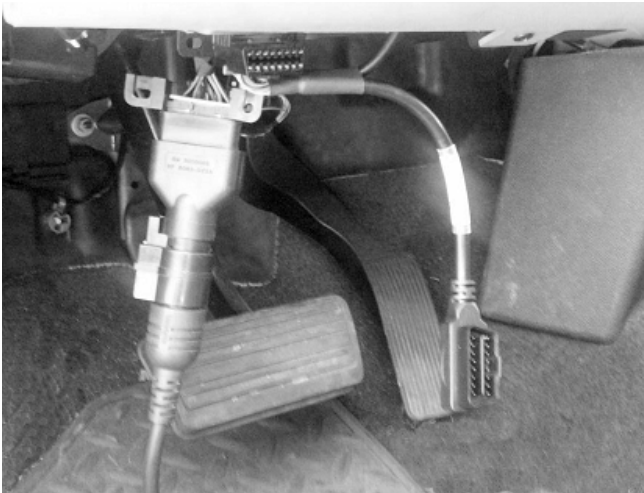
#### Device W/Secondary DLC Connector

This device has another DLC connector on it. The rest of the harness along with the device can be placed out of sight hidden from the technician, who may not notice the diagnostic connector is not in the factory location.

If SI diagnostics do not identify the source of the issue and if the device is available, attempt to duplicate the condition, and then remove the device to determine if the condition is eliminated.
